TIER 1 SEISMIC EVALUATION
Immediate Occupancy Structural Performance Level
Campbell City Hall
Campbell, California

Final Report

December 21, 2017

BCA Job No. 2015274.2

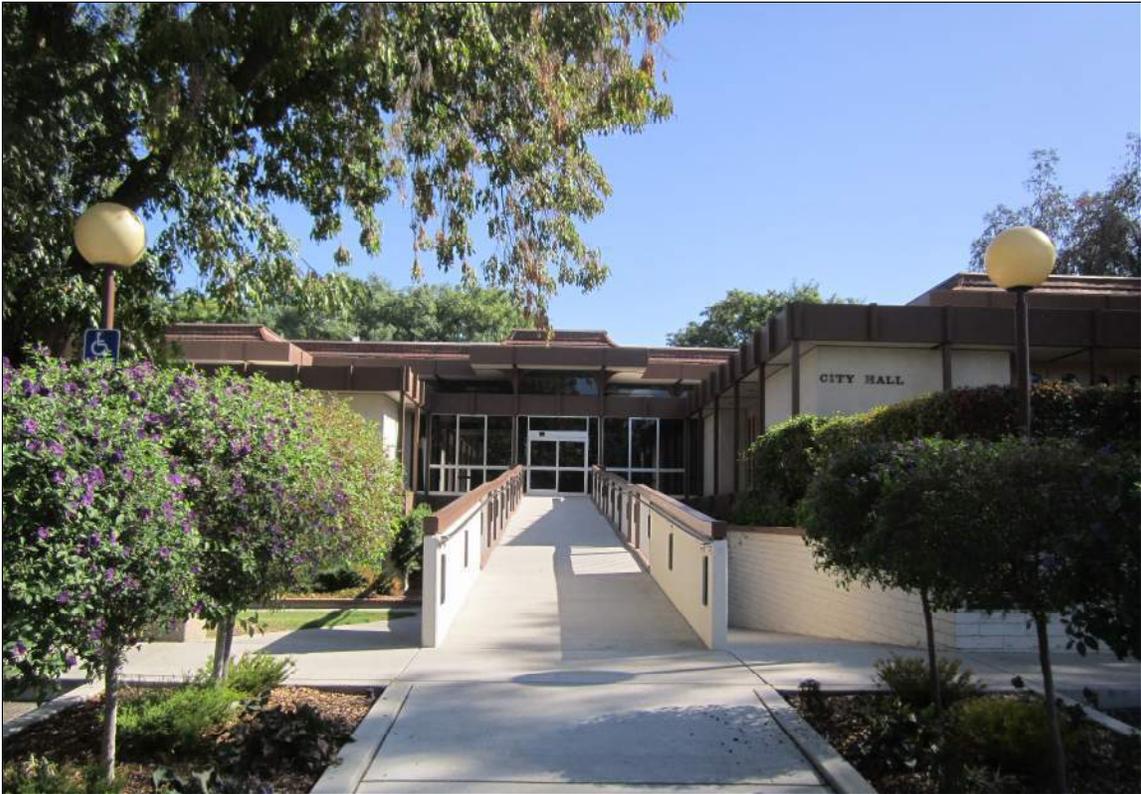
Photo 1 – West elevation view

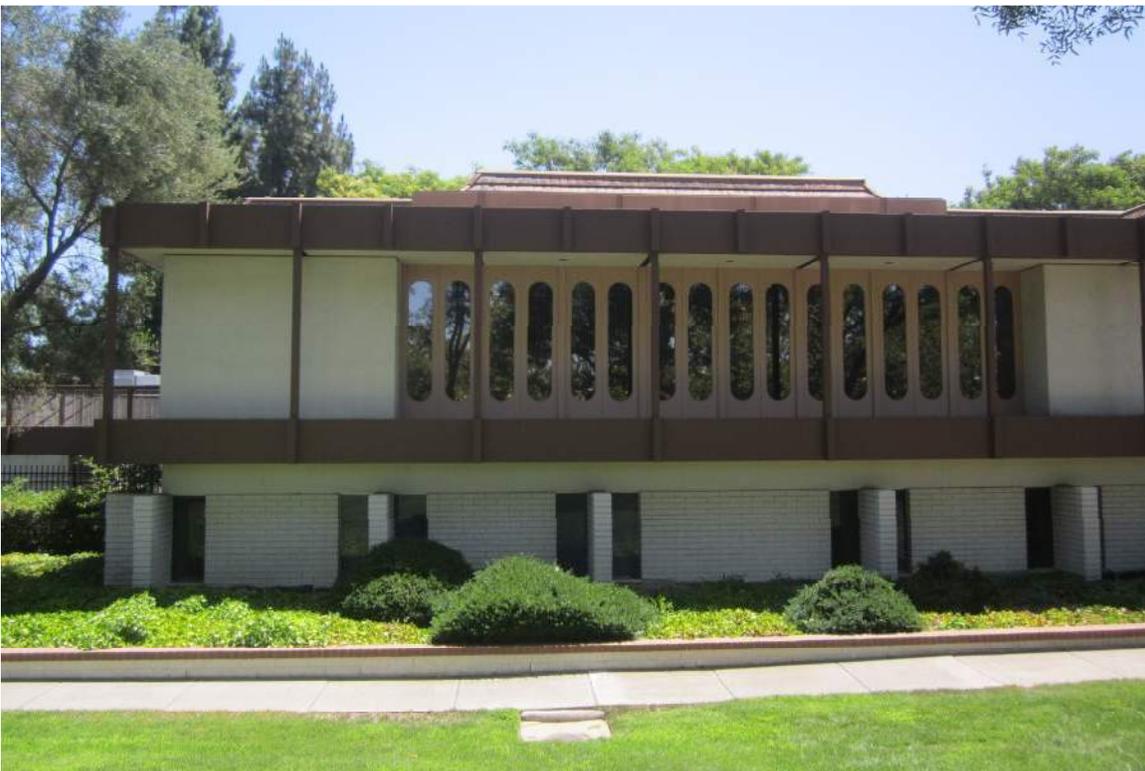
Photo 2 – West elevation view (north end)

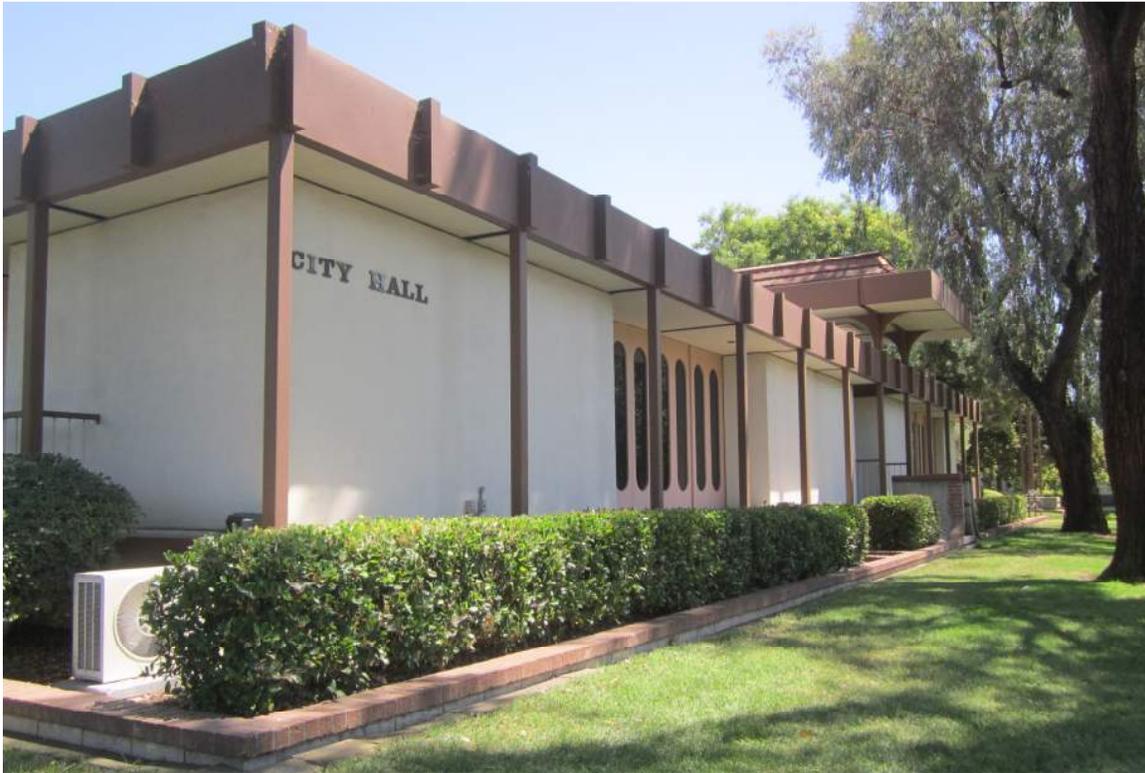
Photo 3 – South elevation view

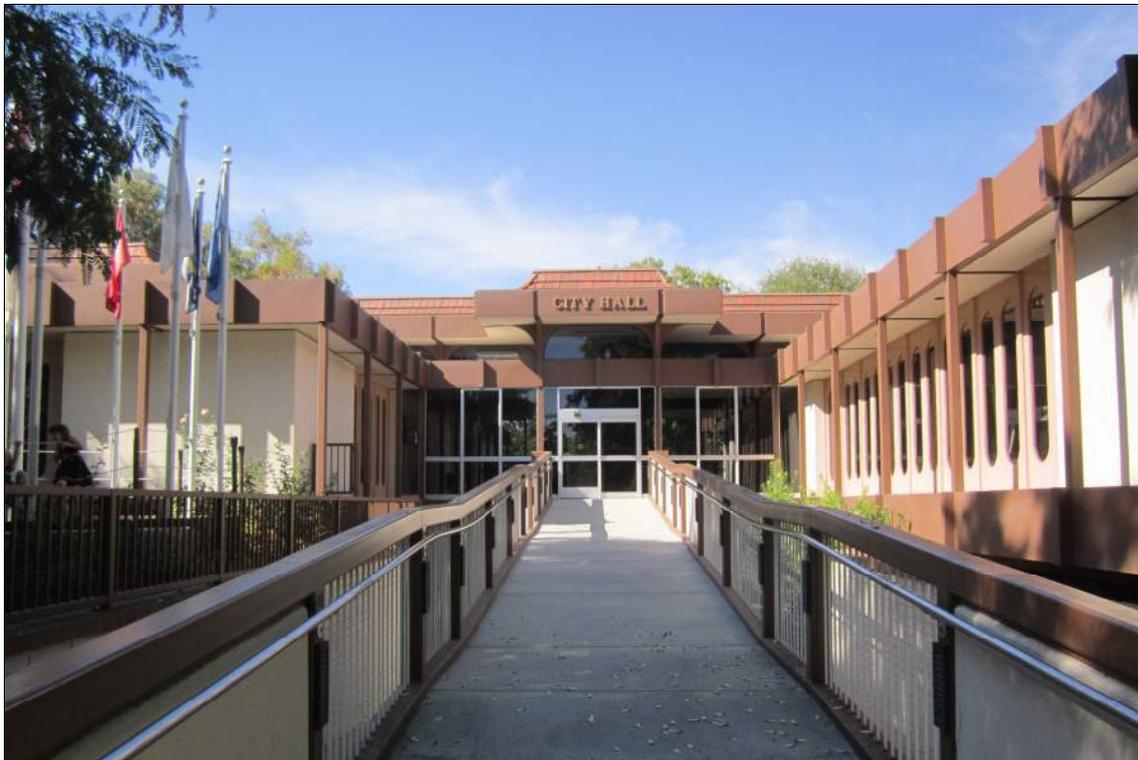
Photo 4 – East entrance view

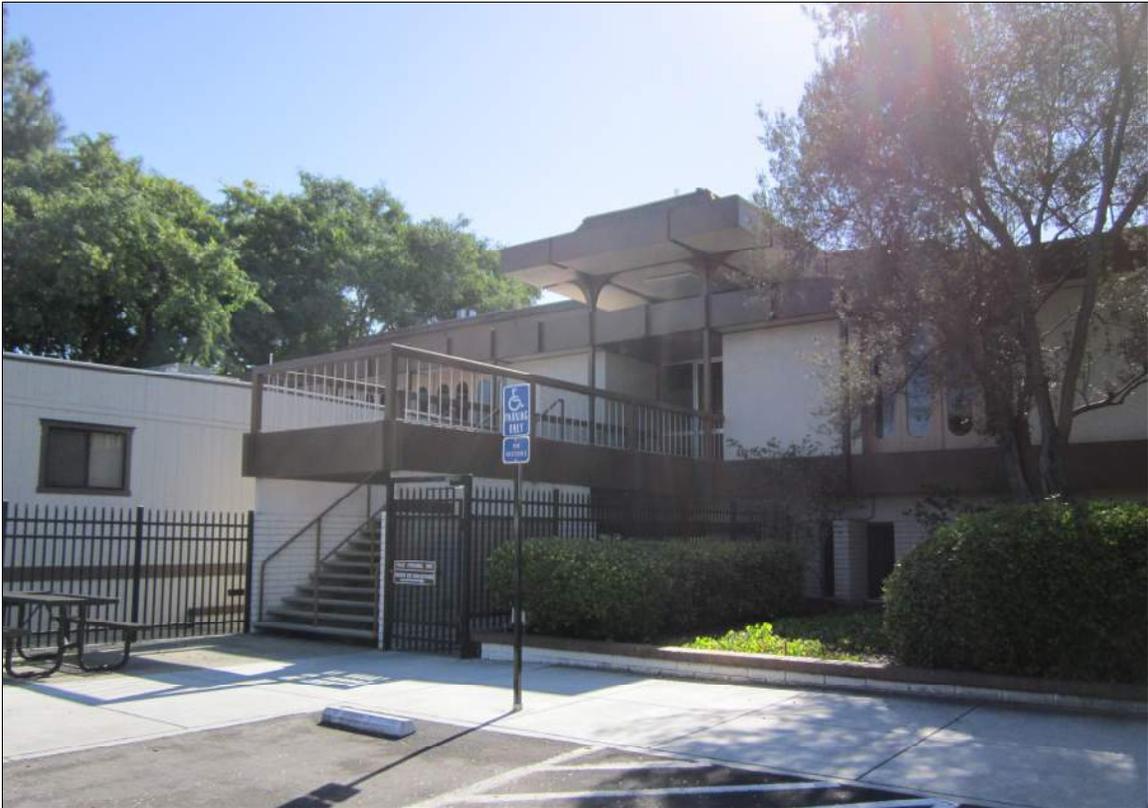
Photo 5 – North elevation view

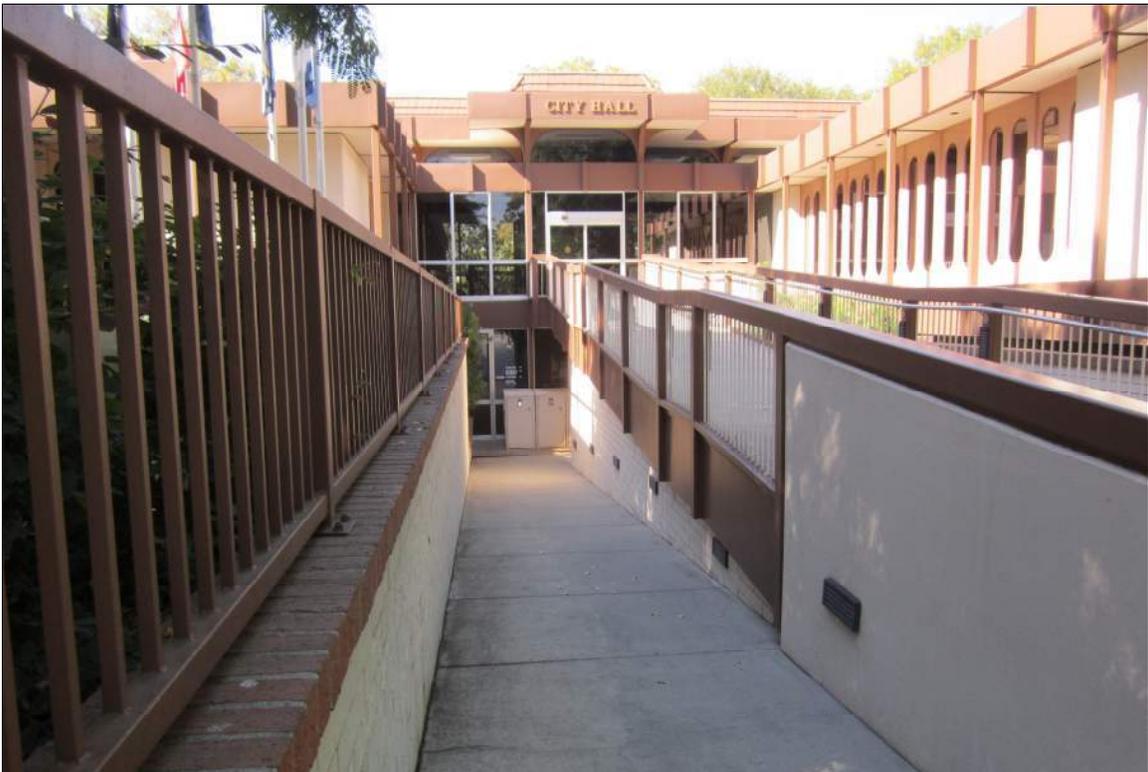
Photo 6 – Ramp at East entrance

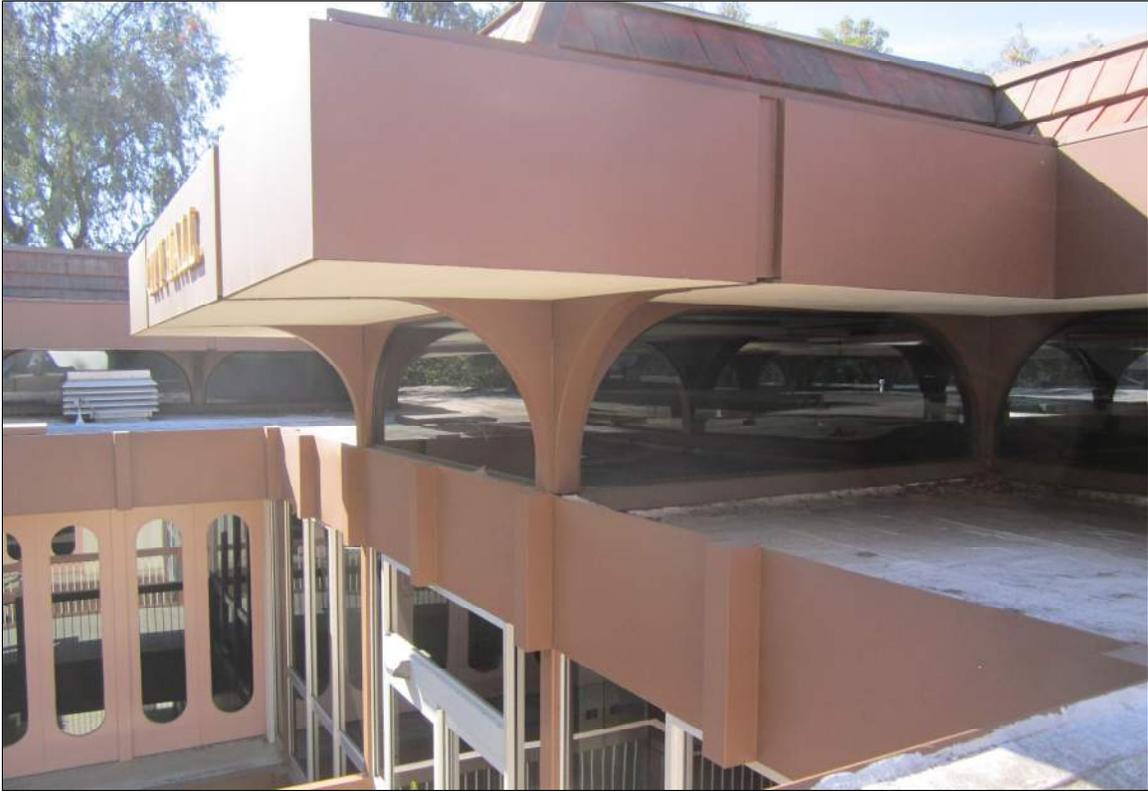
At the high roof of the City Hall, the plywood roof diaphragm transfers lateral forces through the steel cantilevered columns into the lower roof diaphragm. At second story the plywood roof diaphragm transfers lateral forces into the perimeter plywood shear walls. At the first story, the plywood second floor diaphragm transfers lateral forces into the masonry shear walls at perimeter of the building. The forces from the second-story plywood shear walls are transferred directly into the first-story masonry shear walls, which then transfer the combined lateral forces to the foundations.

Photo 7 – High roof with steel cantilevered columns

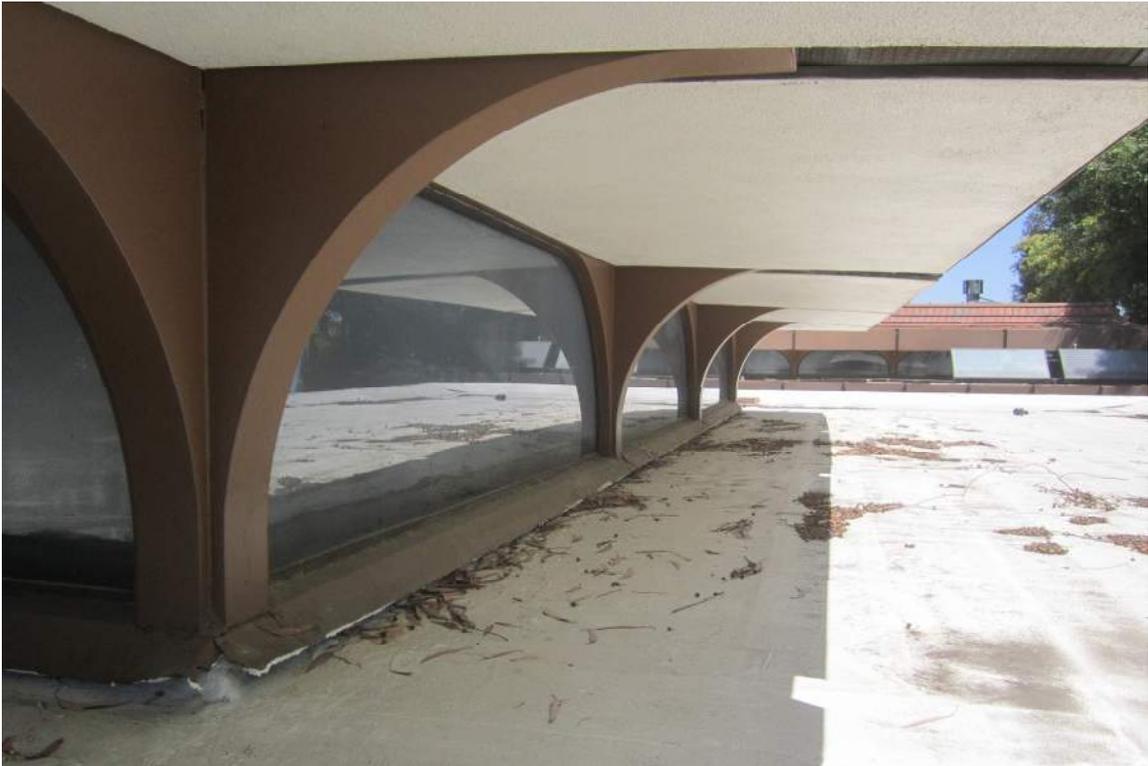
The shear capacities of the roof and second floor plywood diaphragms appear to be adequate for transferring the seismic forces to the shear walls; the details and capacities of the roof diaphragm chords/collectors, however, need strengthening. The steel cantilever columns supporting the high roof appear to be inadequate for transferring the seismic forces into the main roof diaphragm. New lateral elements will need to be added in the clearstory between the high roof and low roof.

Photo 8 – Clearstory at High roof

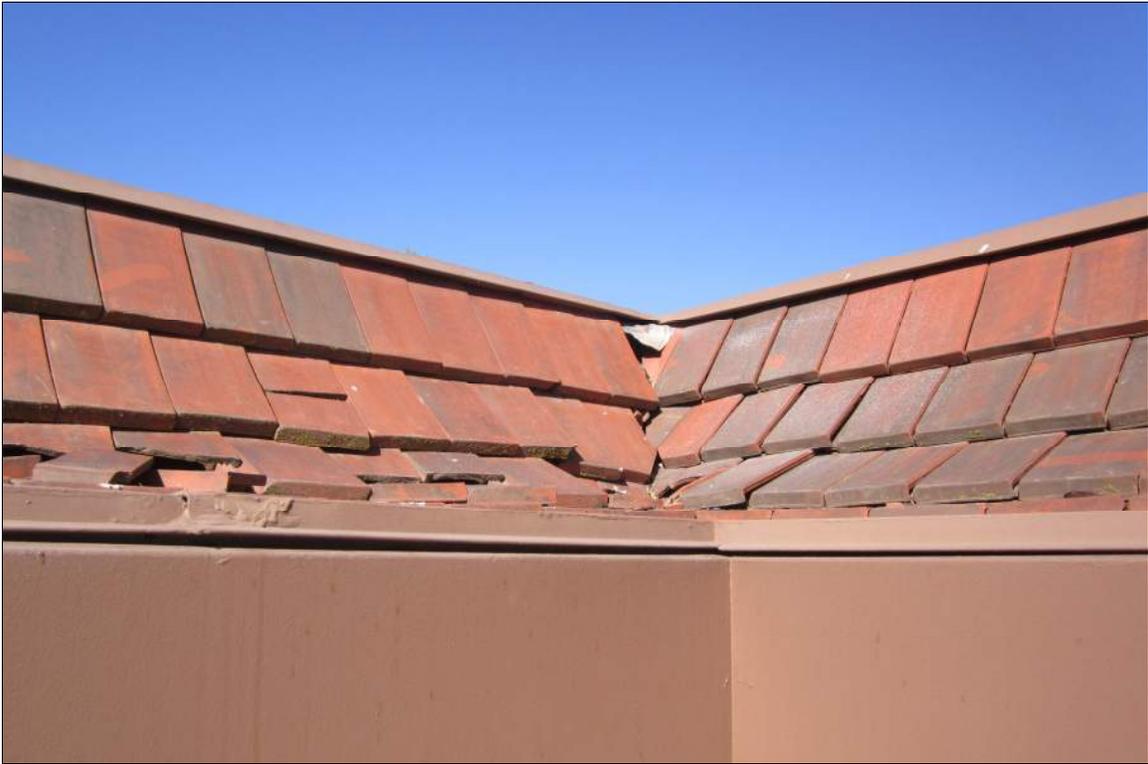
Photo 9 – Broken tiles at upper roof

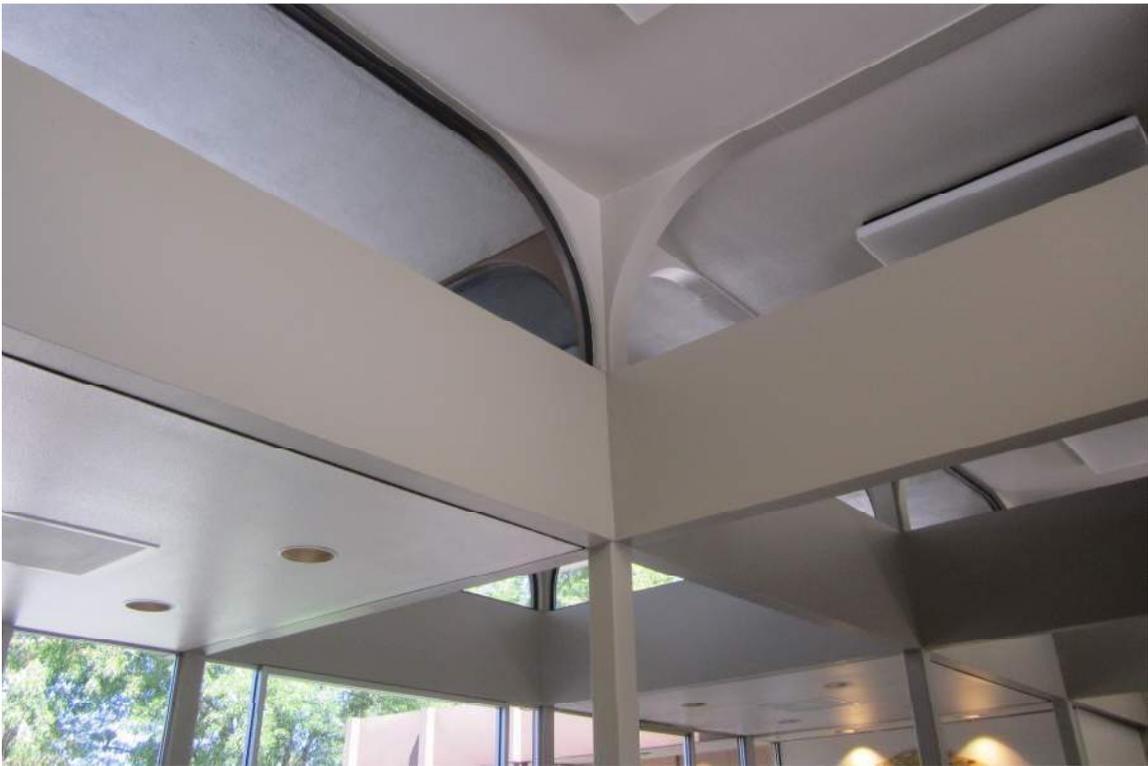
Photo 10 – Interior steel columns at second floor

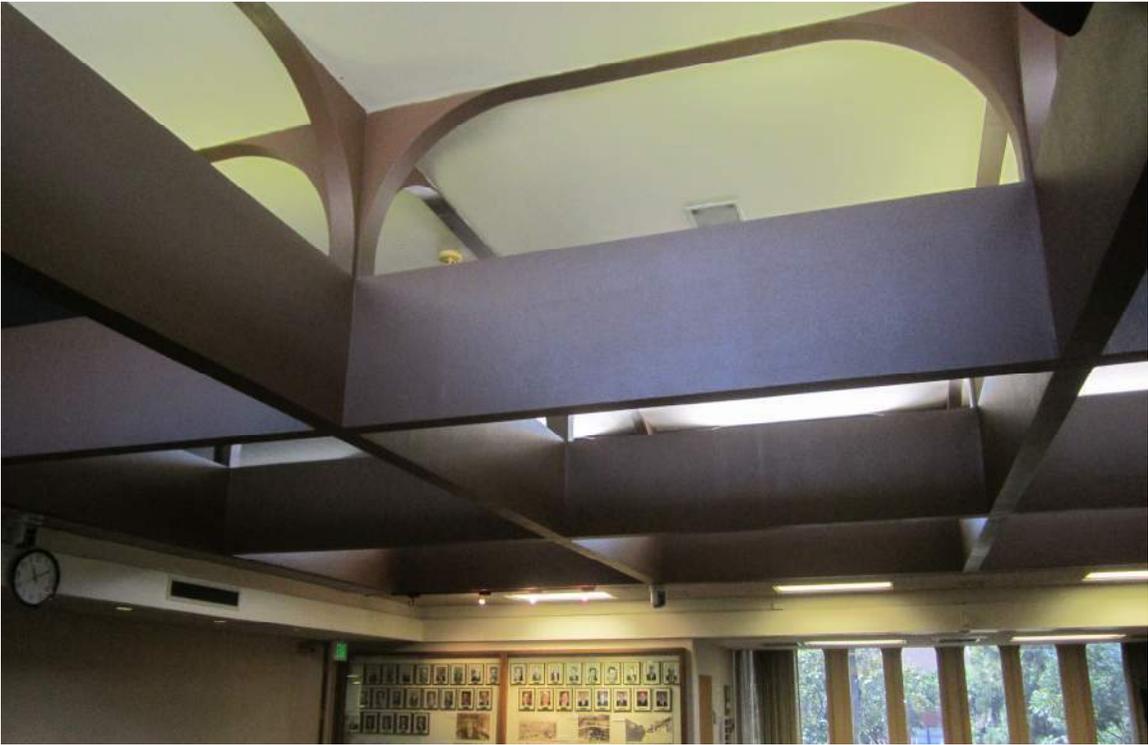
Photo 11 – Interior open roof framing below upper roof

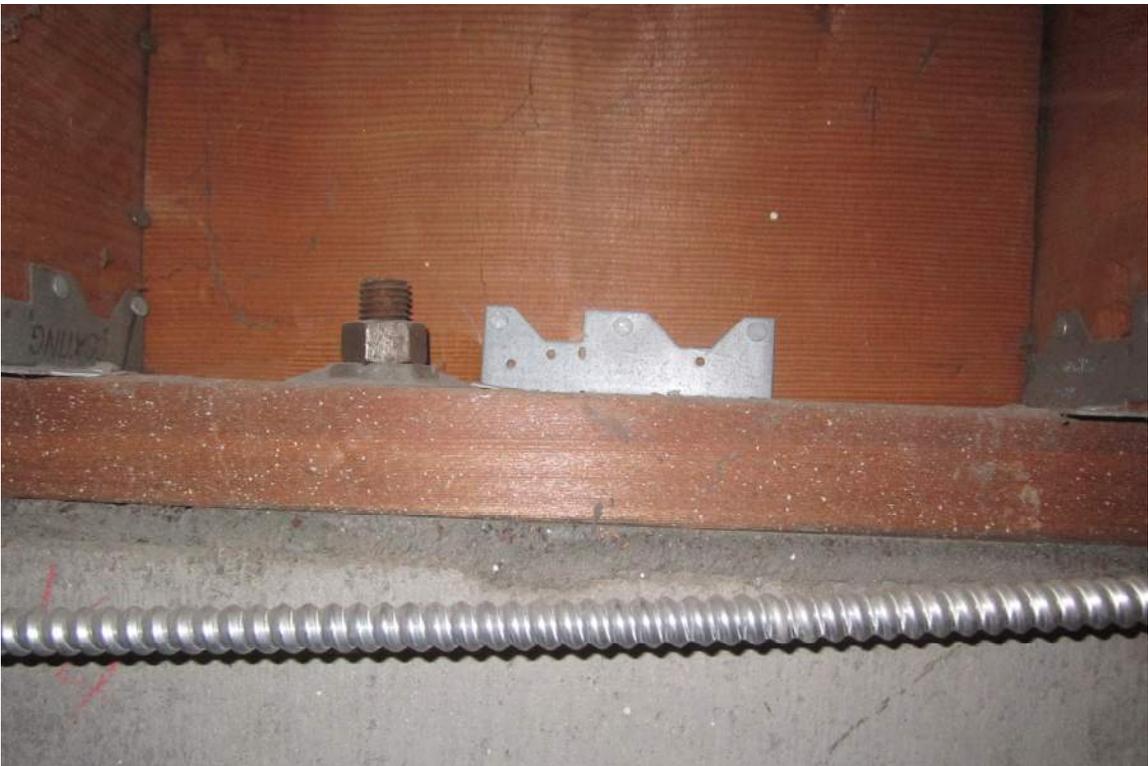
Based on the original structural drawings, the masonry shear walls at the first story are fully grouted and reinforced and appear to be adequate for transferring the in-plane seismic loads to the foundations. The in-plane shear connection between the second floor diaphragm and the masonry walls below consists of wood blocking and steel angle clips attached to a continuous wood sill plate with anchor bolts embedded into the masonry wall at each joist. This connection appears to be inadequate for transferring the seismic loads. New anchor bolts will need to be drilled and epoxied through the wood sill and into the masonry walls.

Photo 12 – Bolted wood sill plate at masonry wall

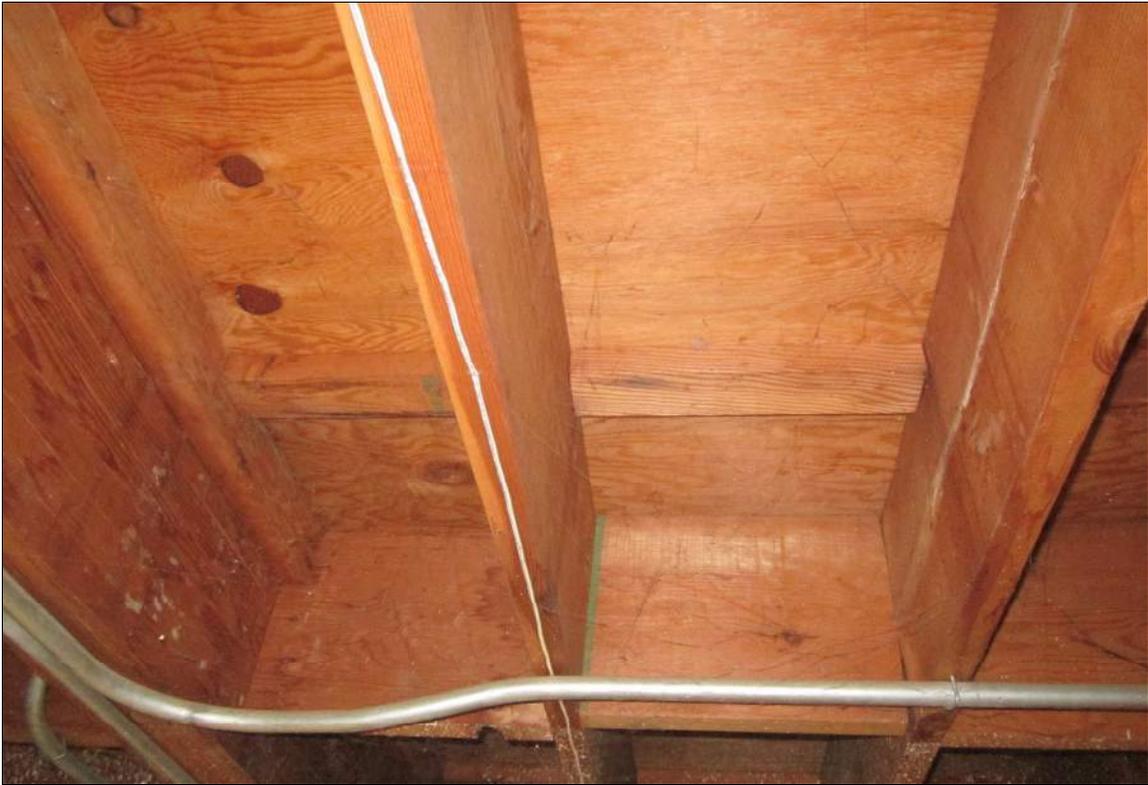
Photo 13 – Wood floor joists

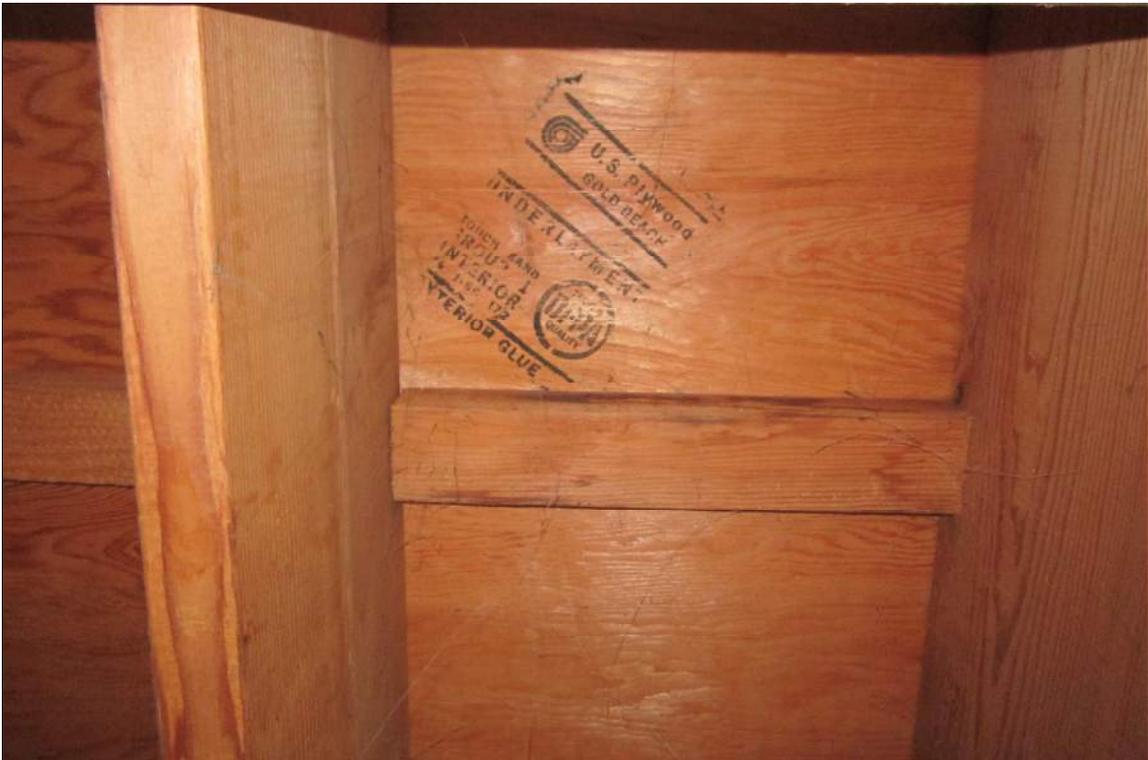
Photo 14 – Wood blocking at plywood diaphragm

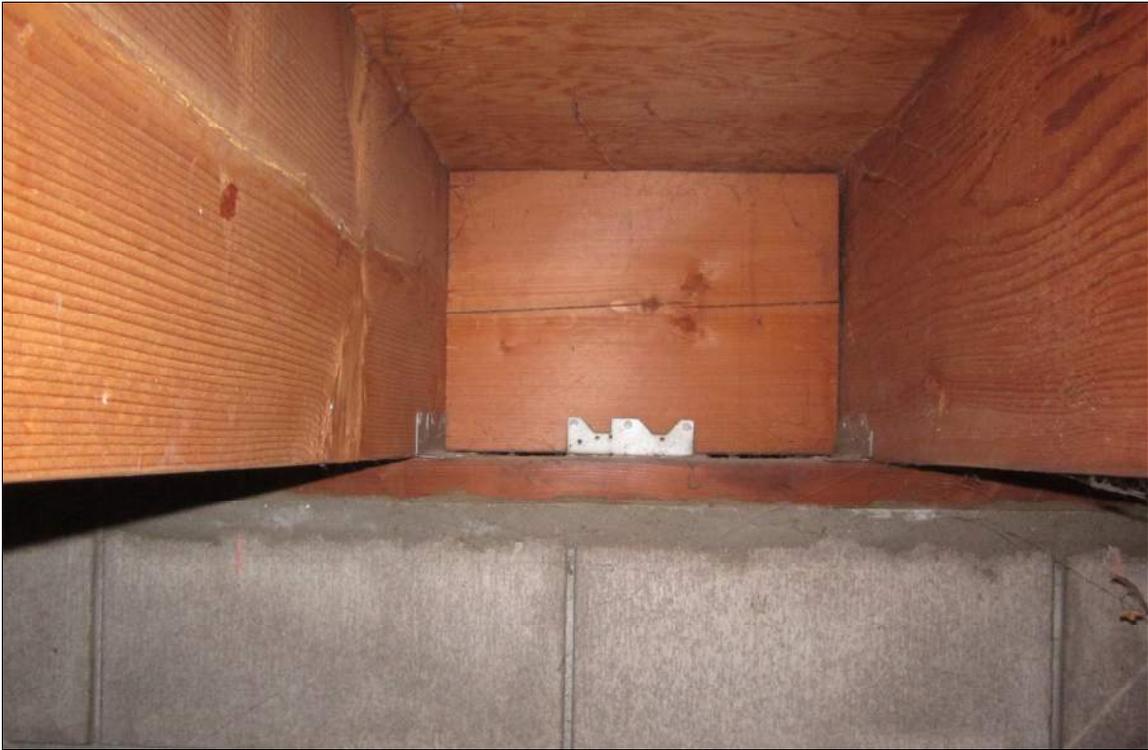
Photo 15 – Simpson steel clips at floor framing

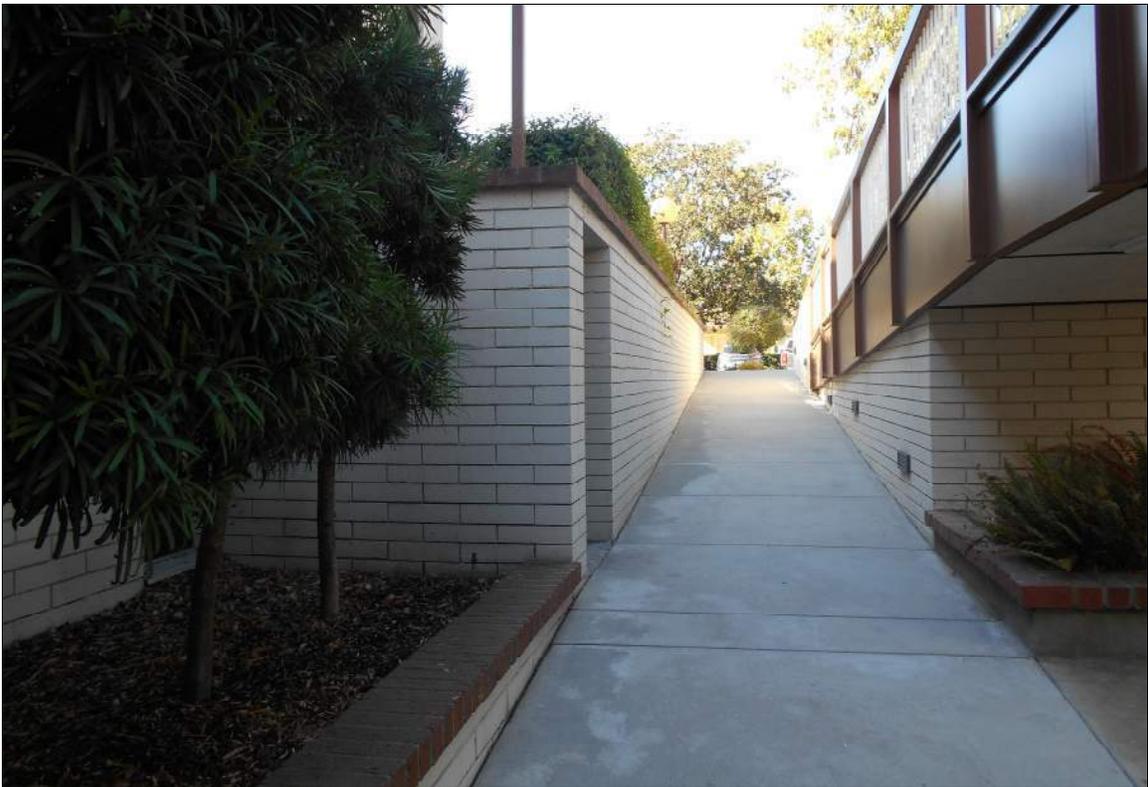
Photo 16 – Ramp at West elevation

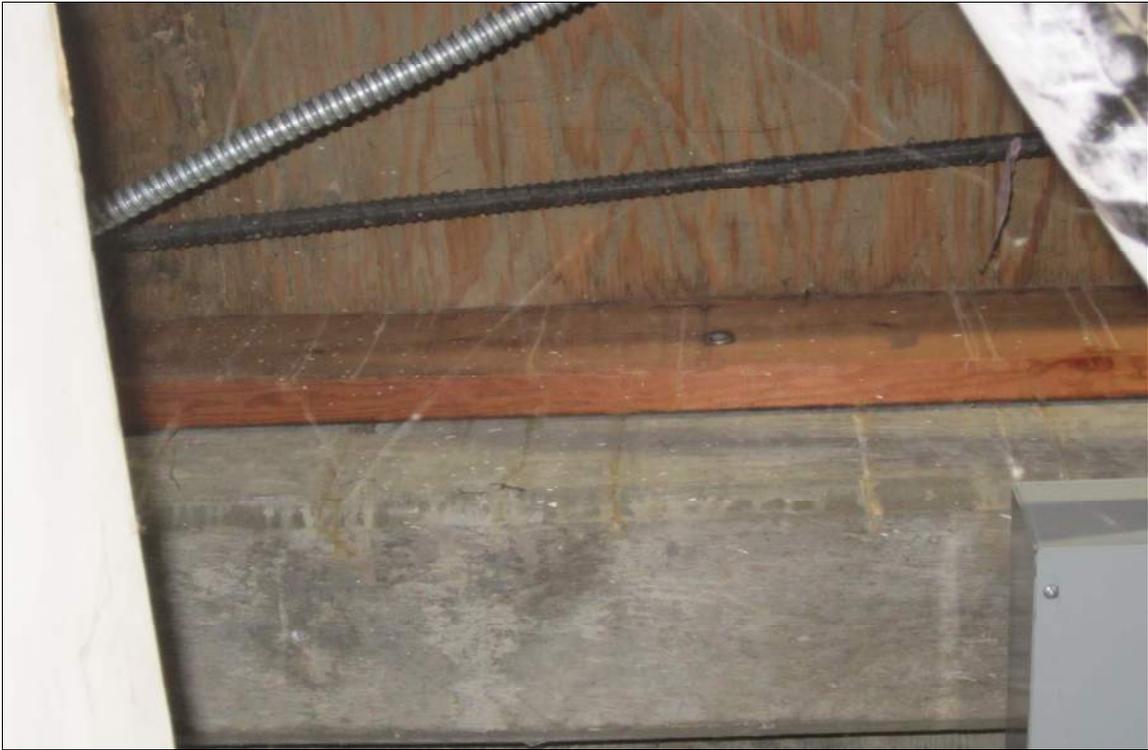
Photo 17 – Wood ledger at concrete vault

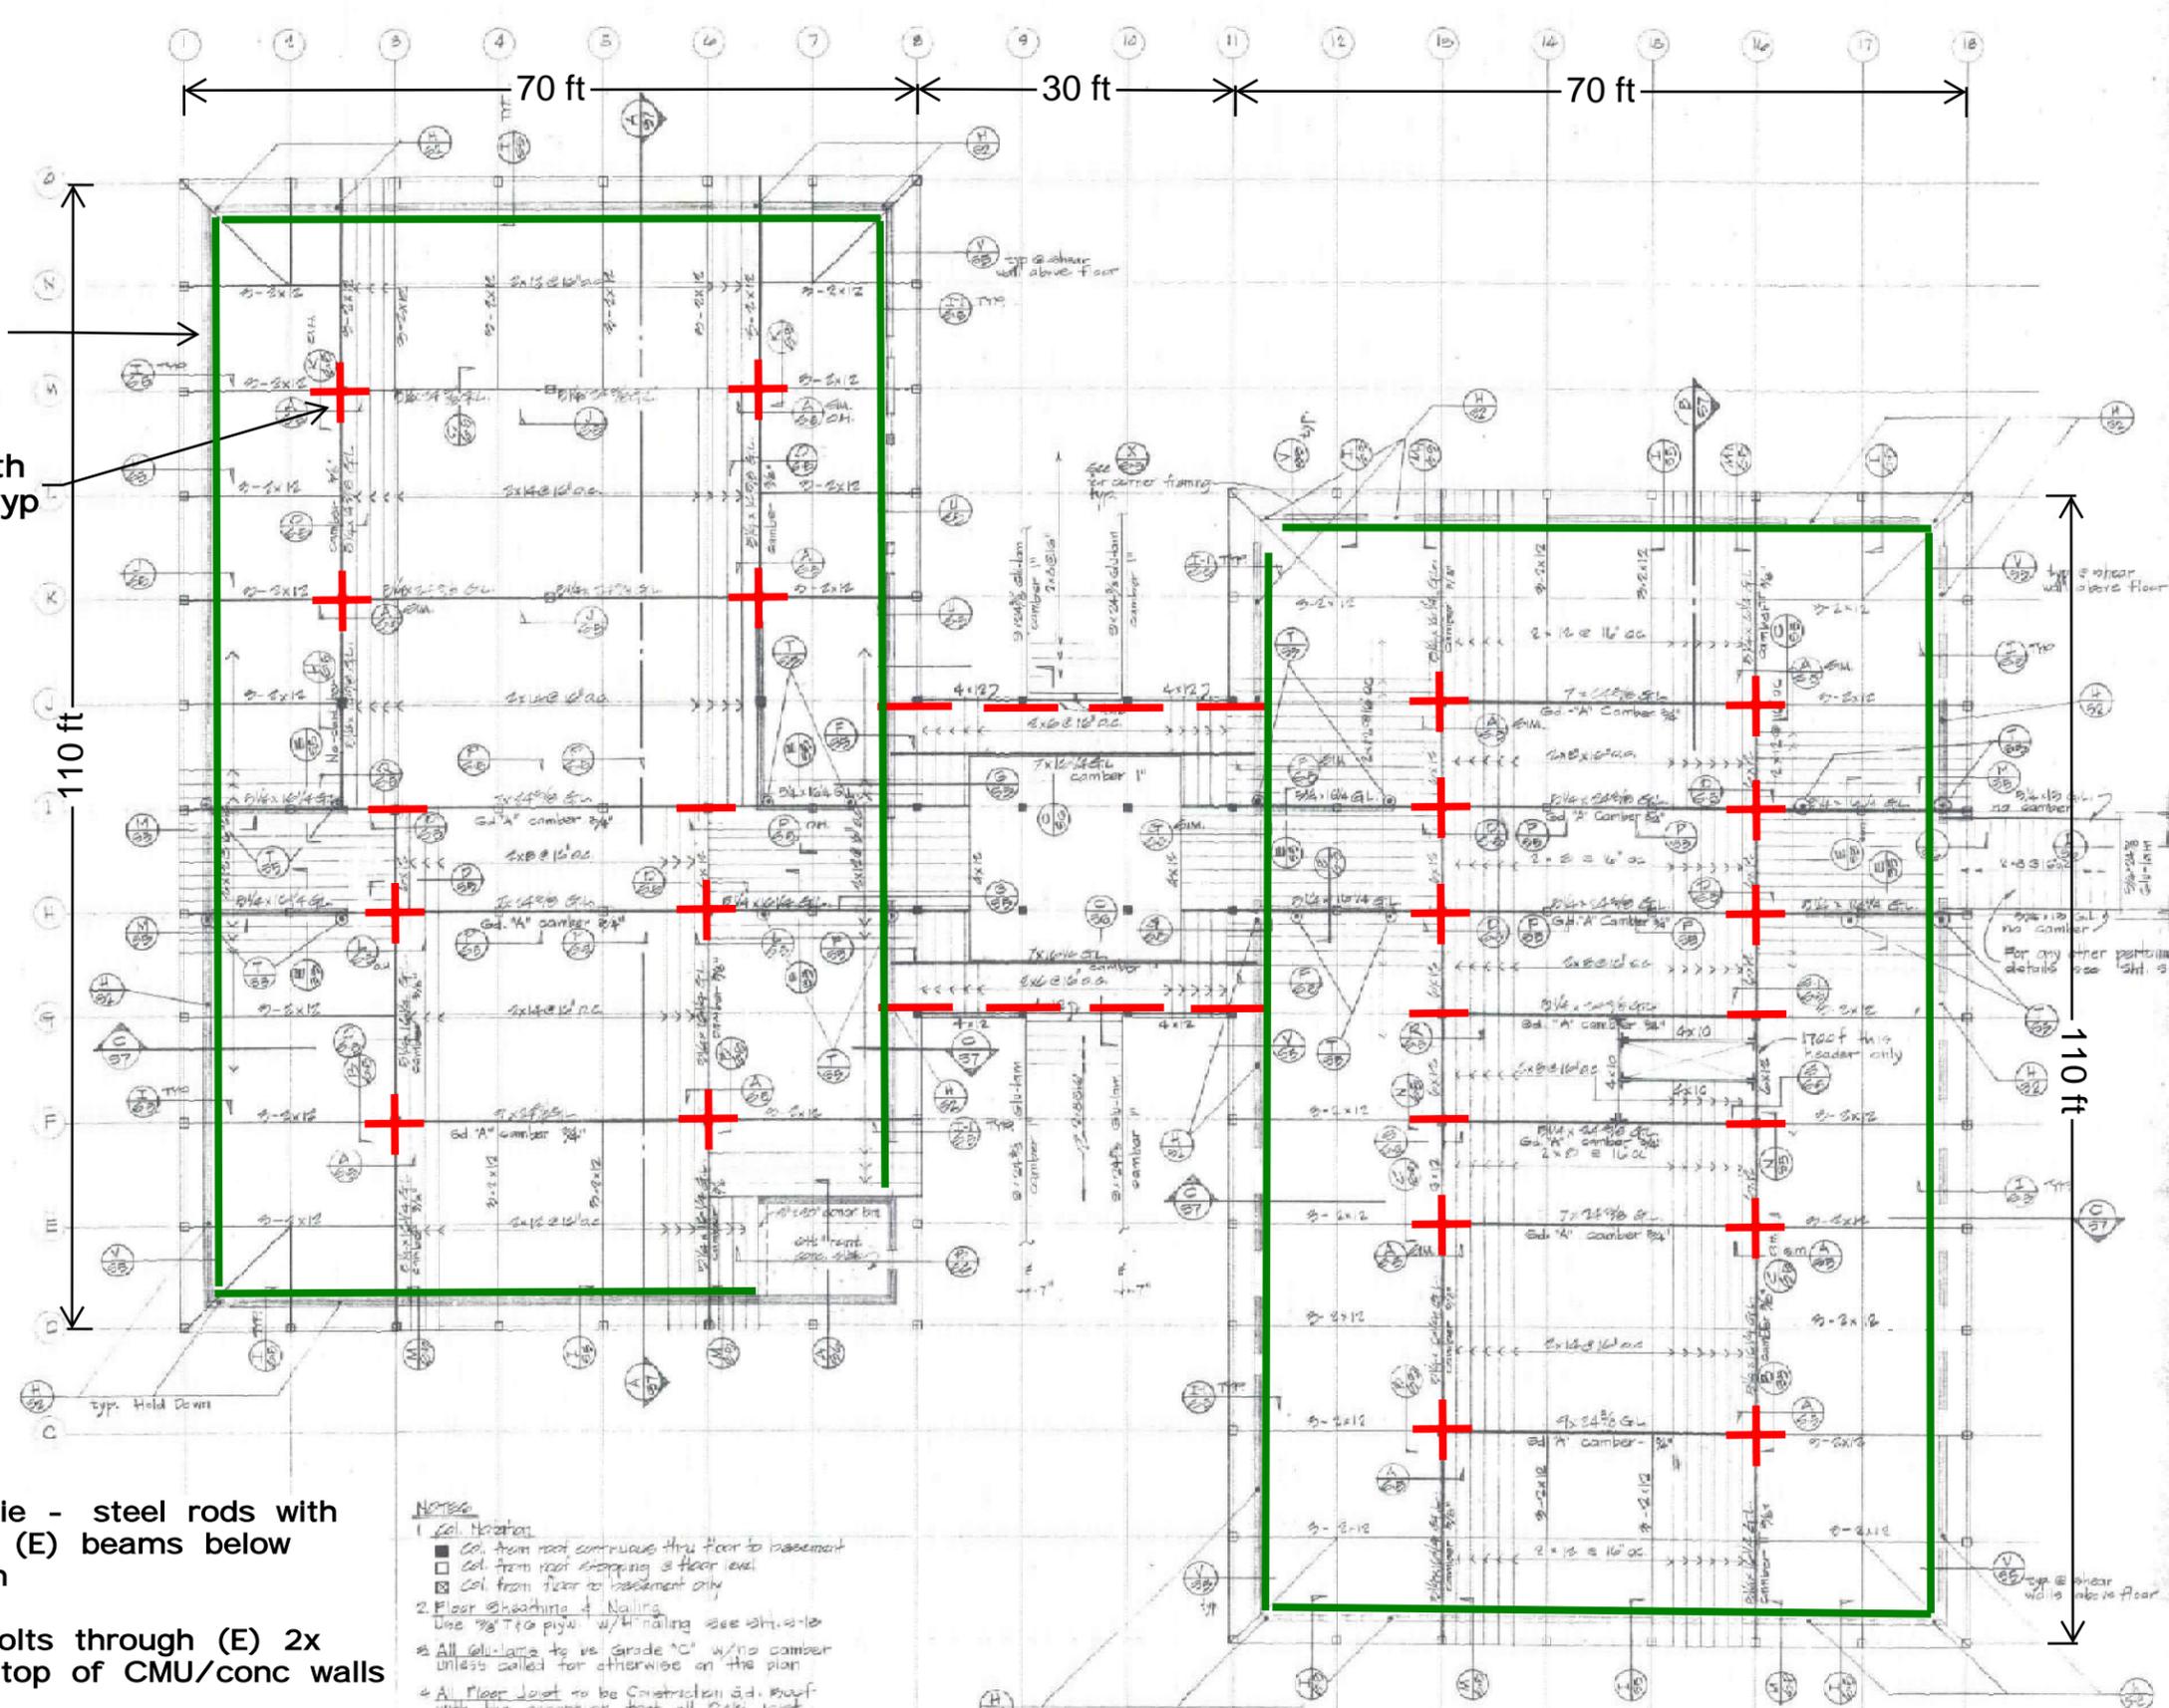
(E) Concrete masonry shearwall below, typ

Holdowns with steel rods, typ

(E) Wood shearwall below, typ

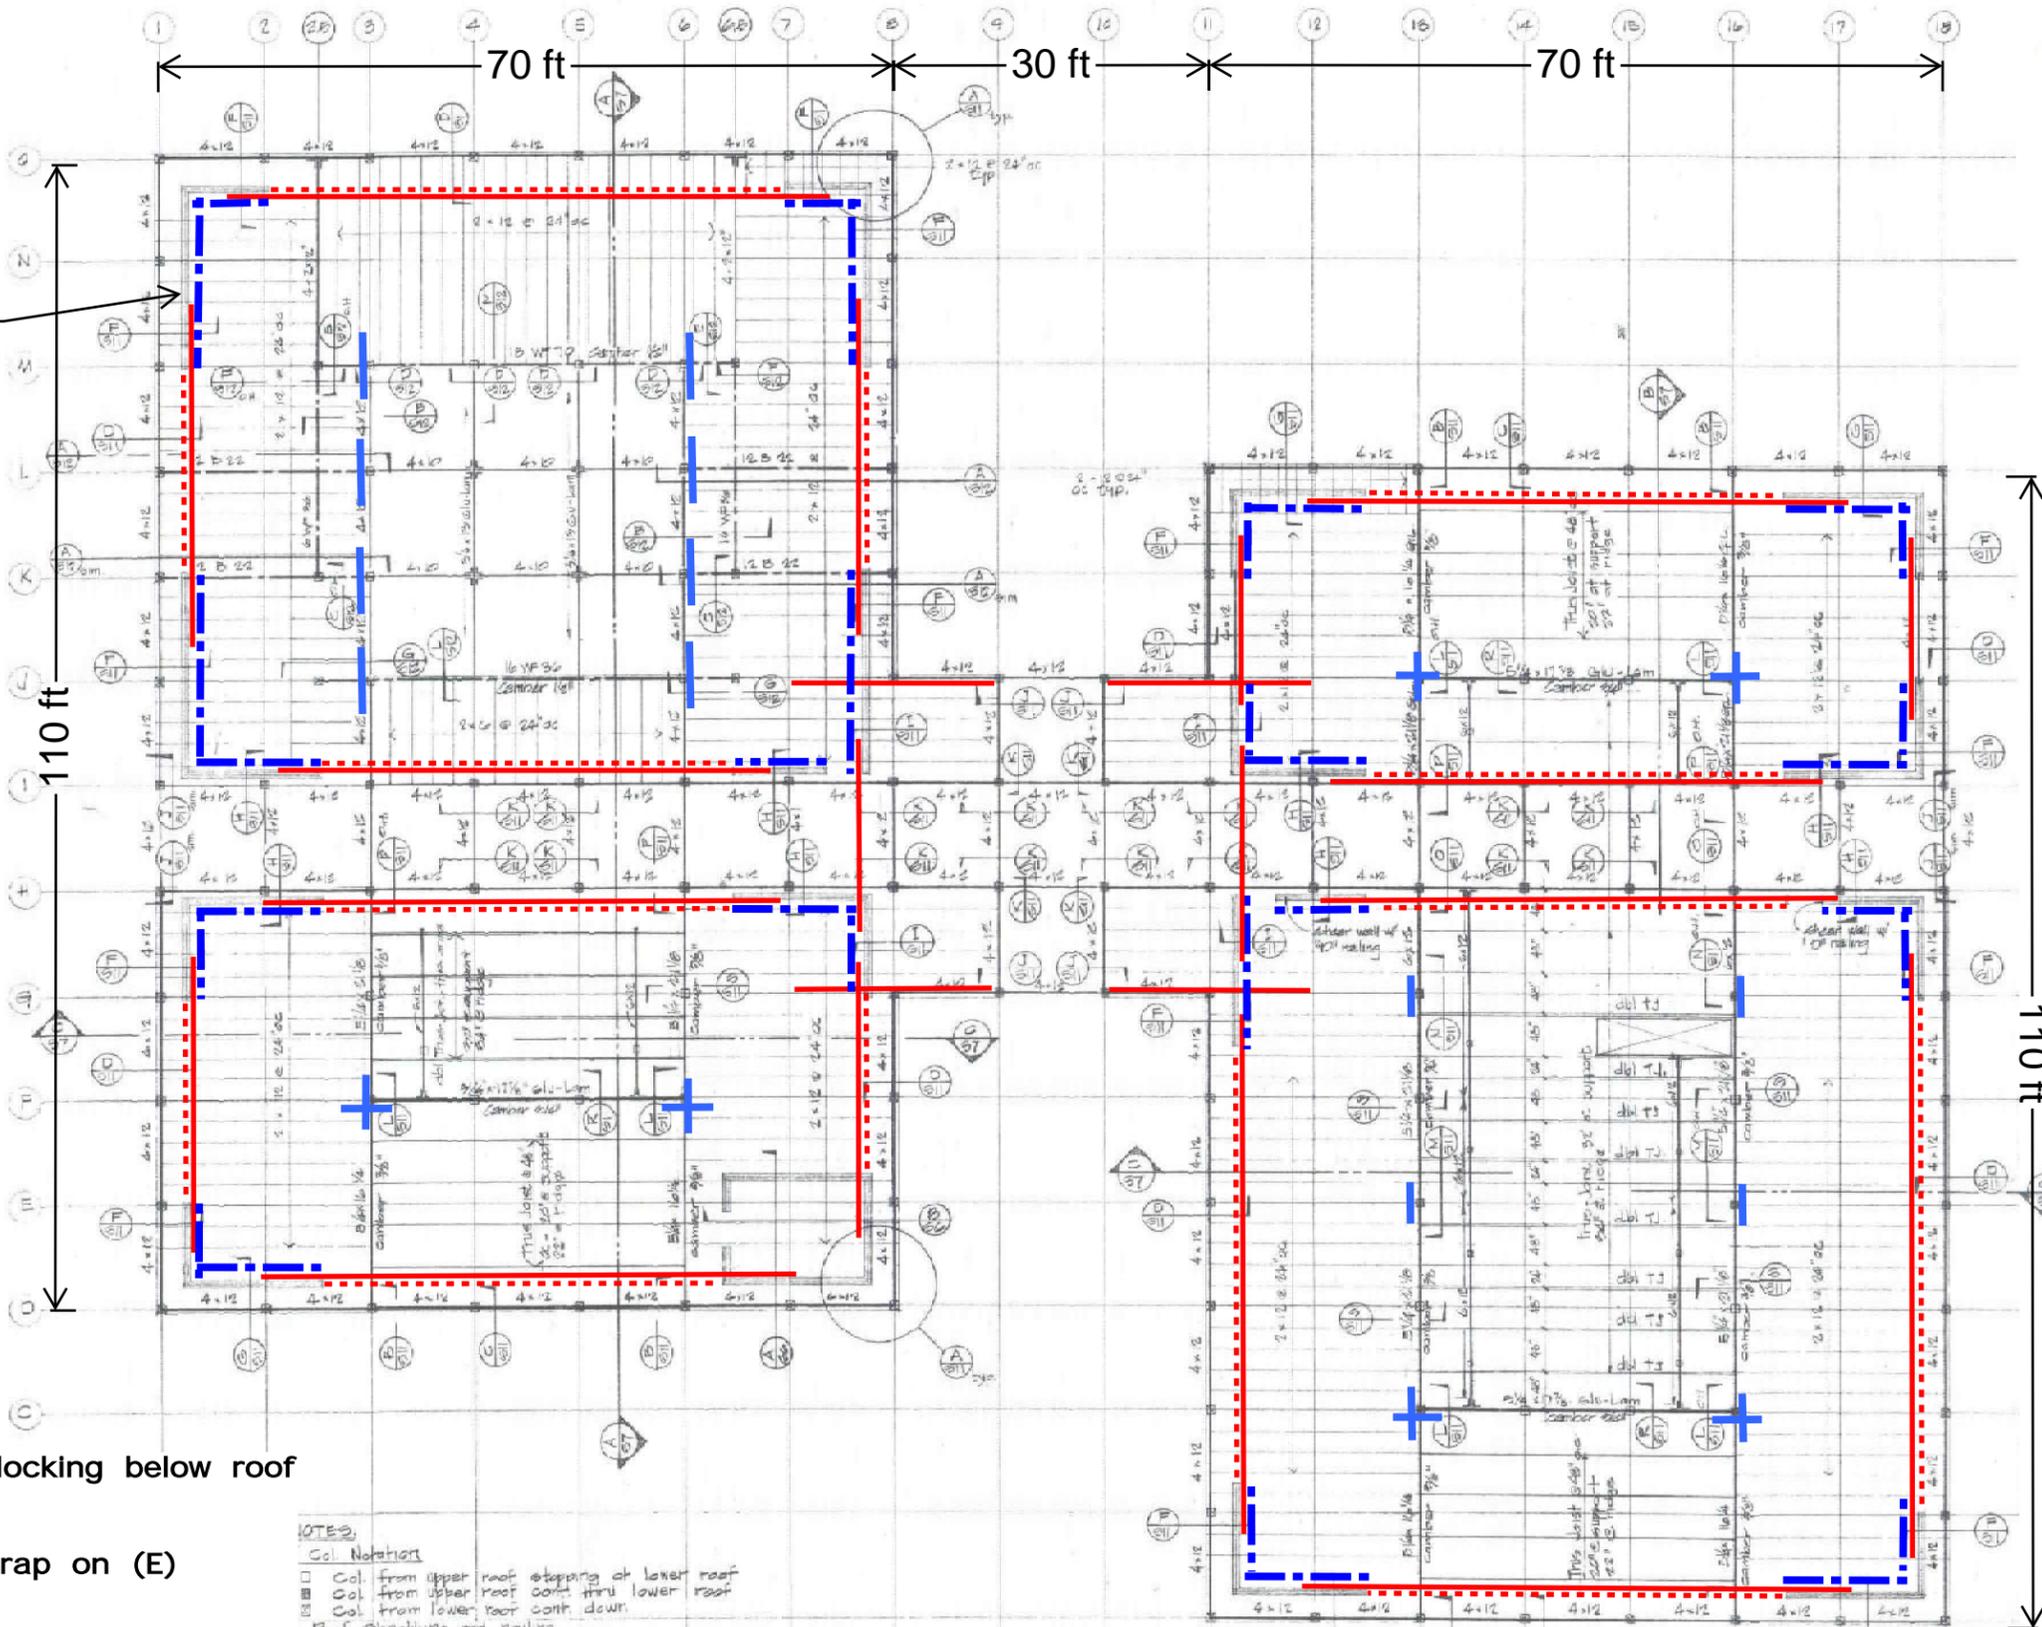
- - - - - Indicates (N) wood blocking below roof diaphragm
- Indicates (N) steel strap on (E) plywood diaphragm
- - - - - Indicates additional (N) plywood at (E) shearwalls with holdowns
- Indicates (N) seismic tie - steel rods with holdowns each side of (E) beams below lower roof diaphragm
