TIER 1 SEISMIC EVALUATION
Immediate Occupancy Structural Performance Level
Campbell City Hall
Campbell, California

Final Report

December 21, 2017

BCA Job No. 2015274.2

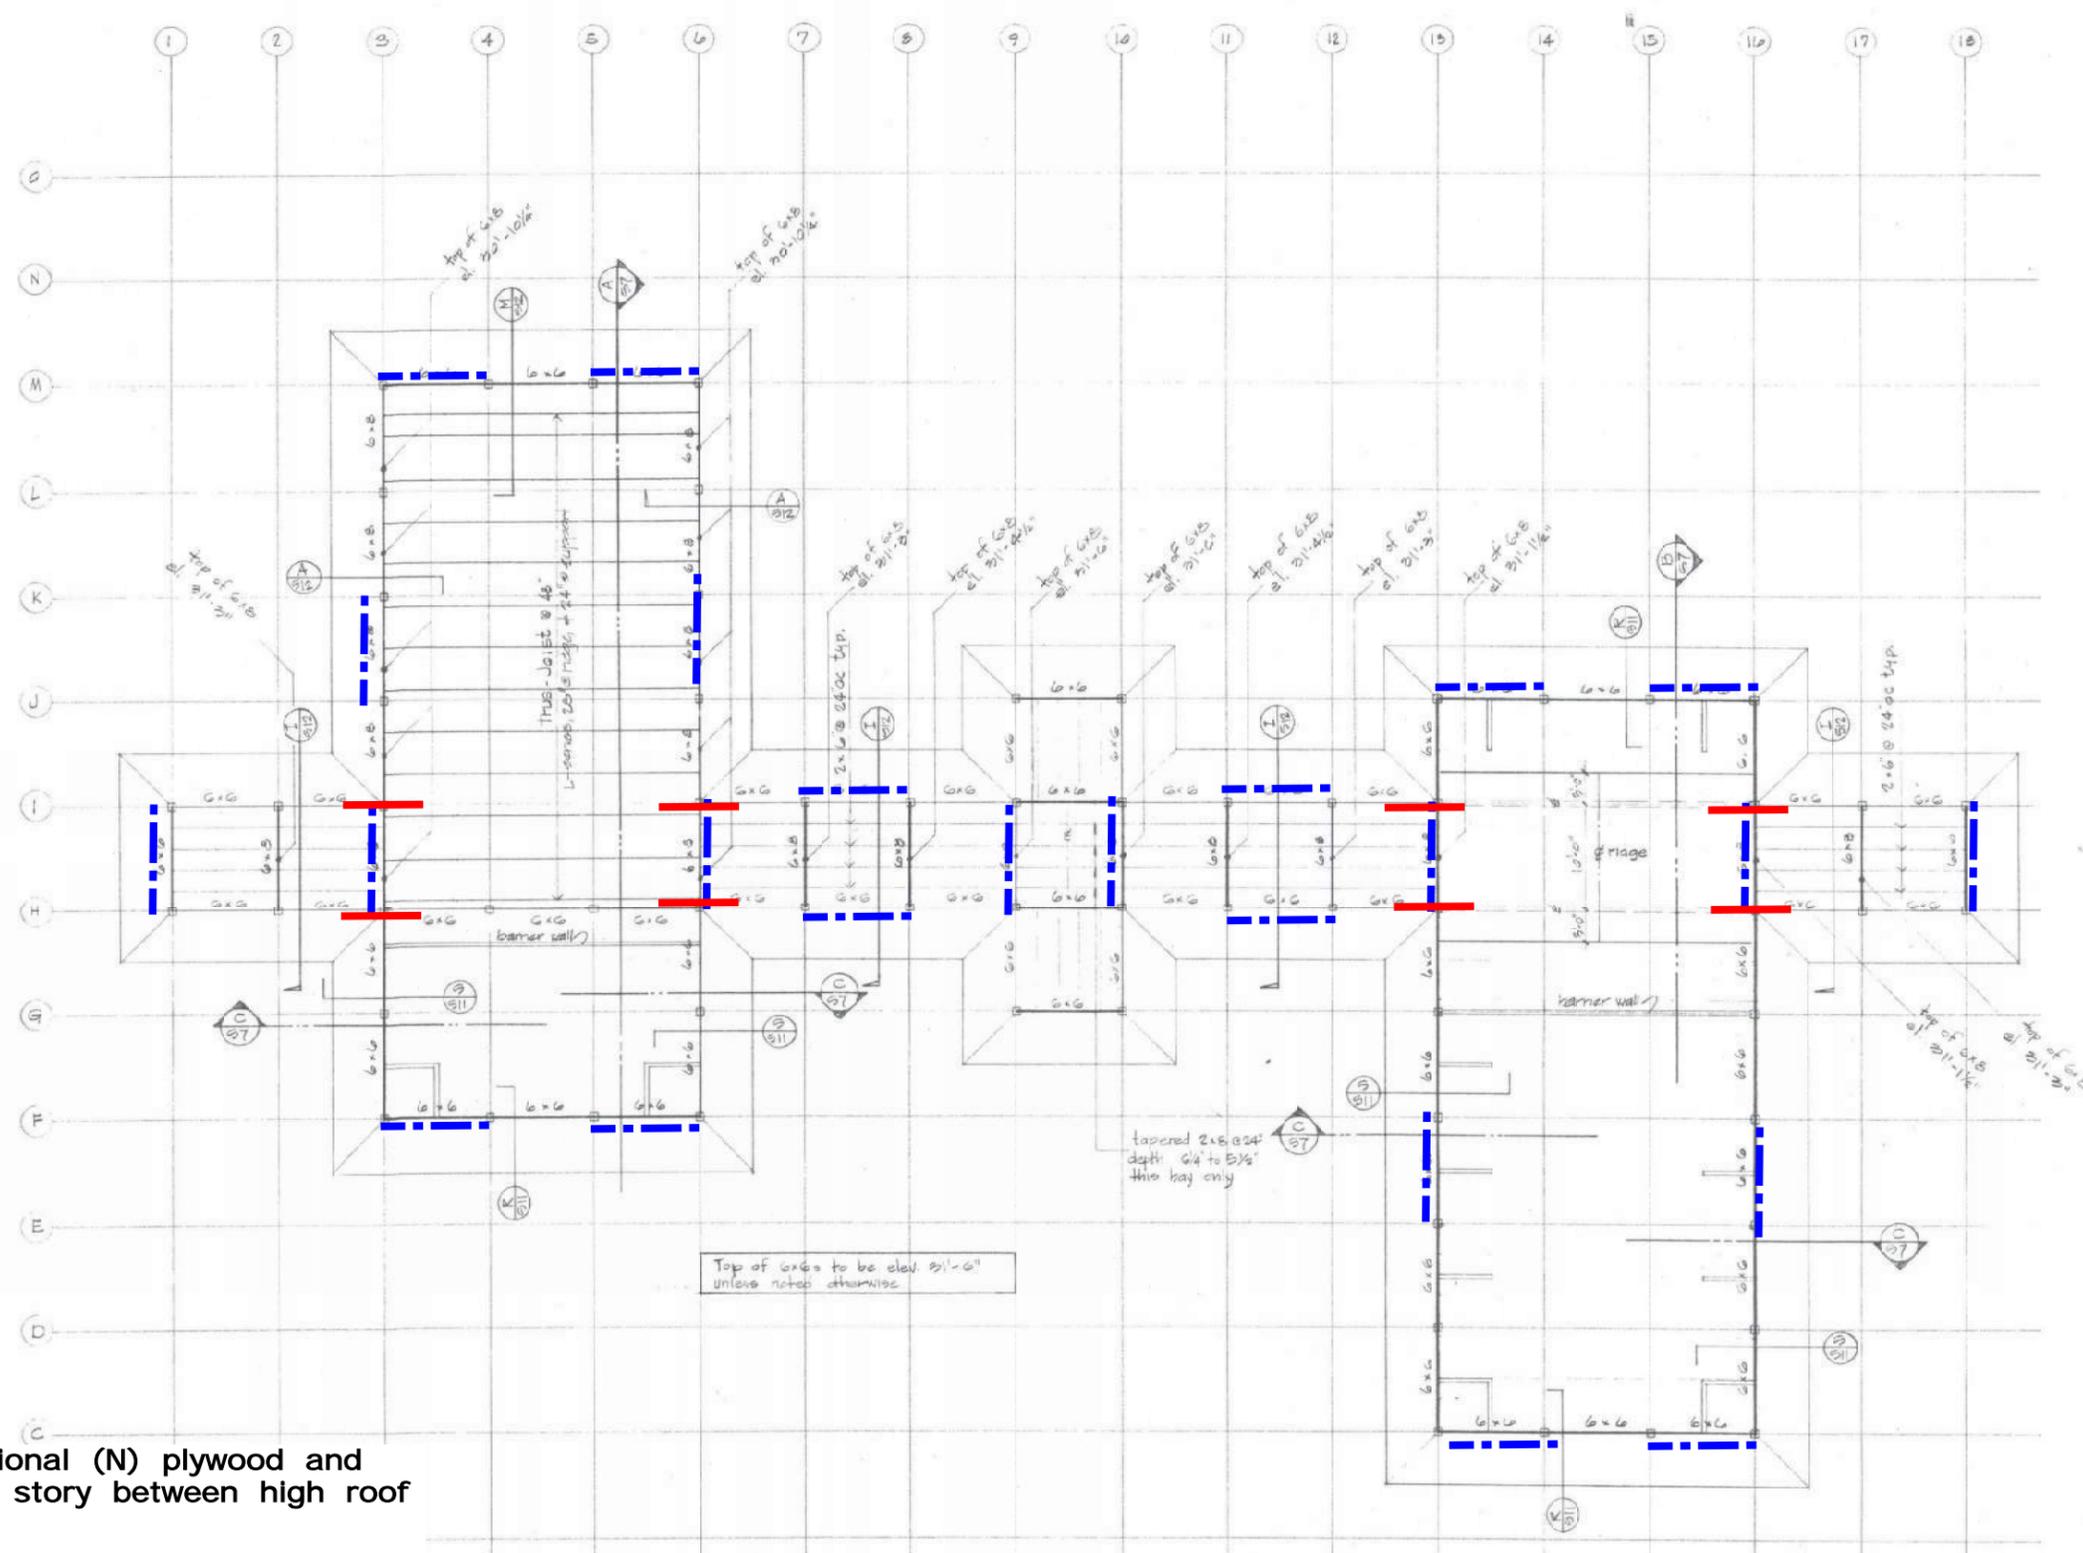
- - - - - Indicates additional (N) plywood and studs at clear story between high roof and low roof

————— Indicates (N) seismic tie - steel rods with holdowns each side of (E) beams below high roof
