**TIER 1 SEISMIC EVALUATION**  
Life Safety Structural Performance Level  
**Campbell City Hall**  
Campbell, California

**Final Report**

Prepared For:  
**City of Campbell**  
70 North First Street  
Campbell, California

December 16, 2015

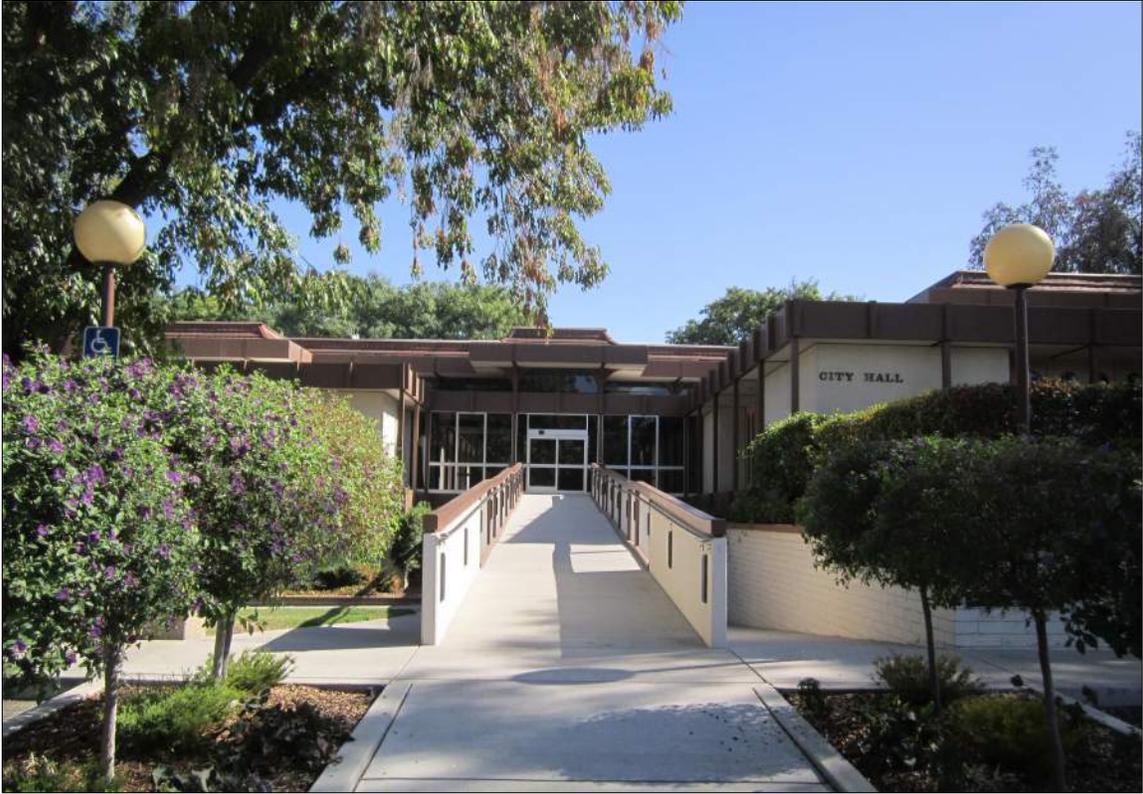
Photo 1 – West elevation view

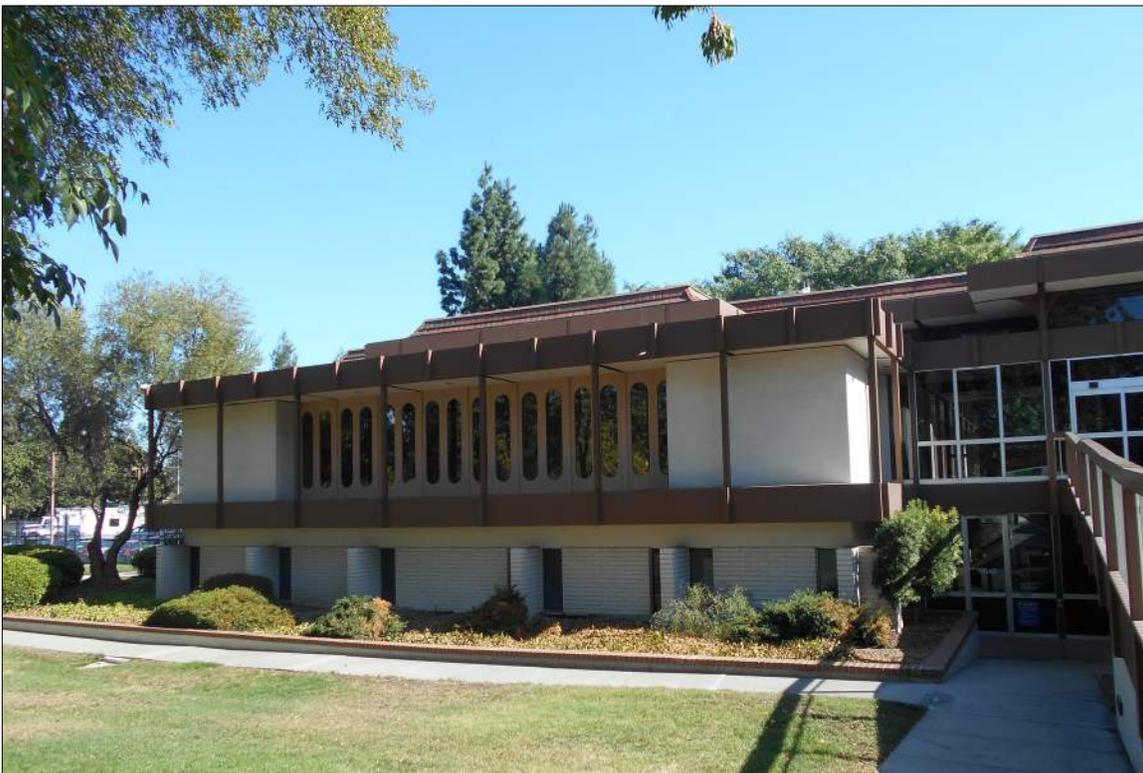
Photo 2 – West elevation view (north end)

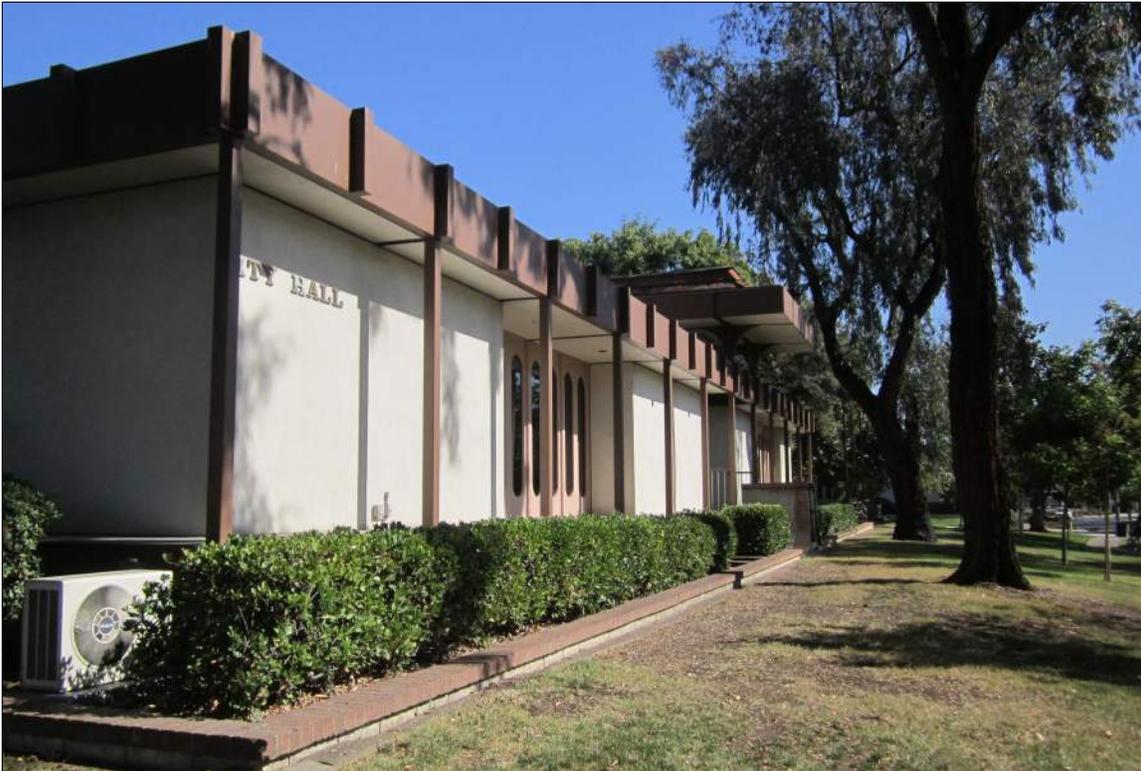
**Photo 3 – South elevation view**

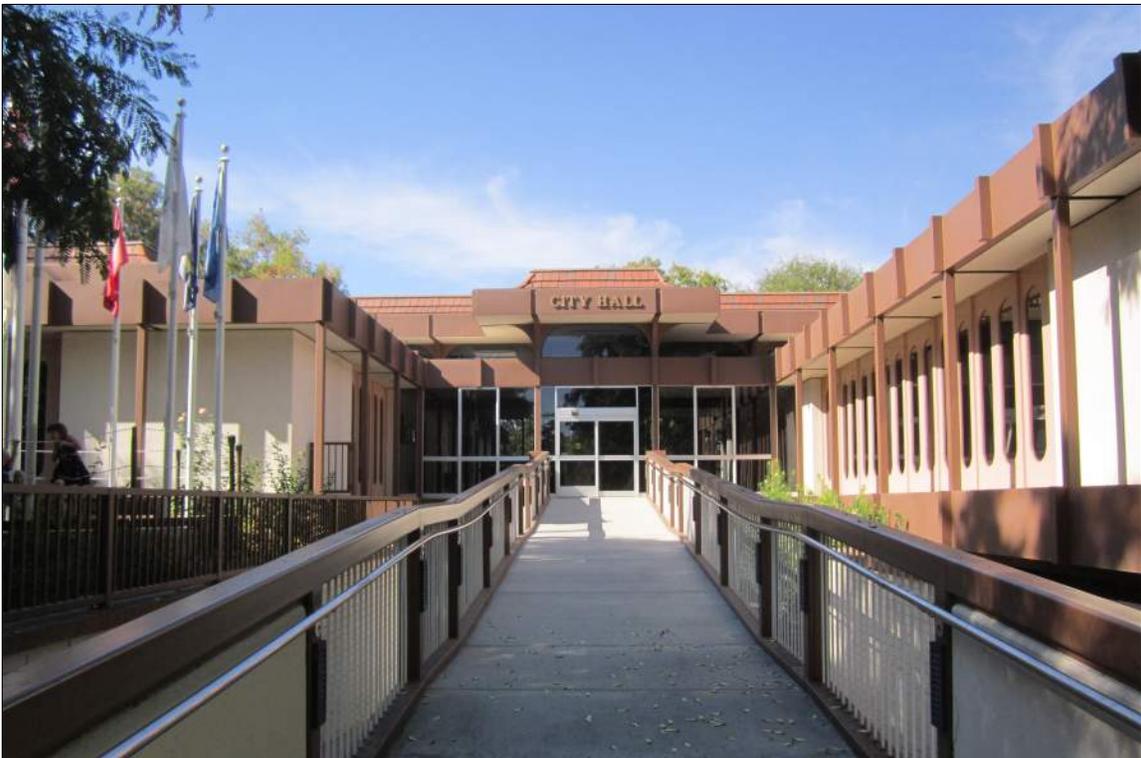
**Photo 4 – East entrance view**

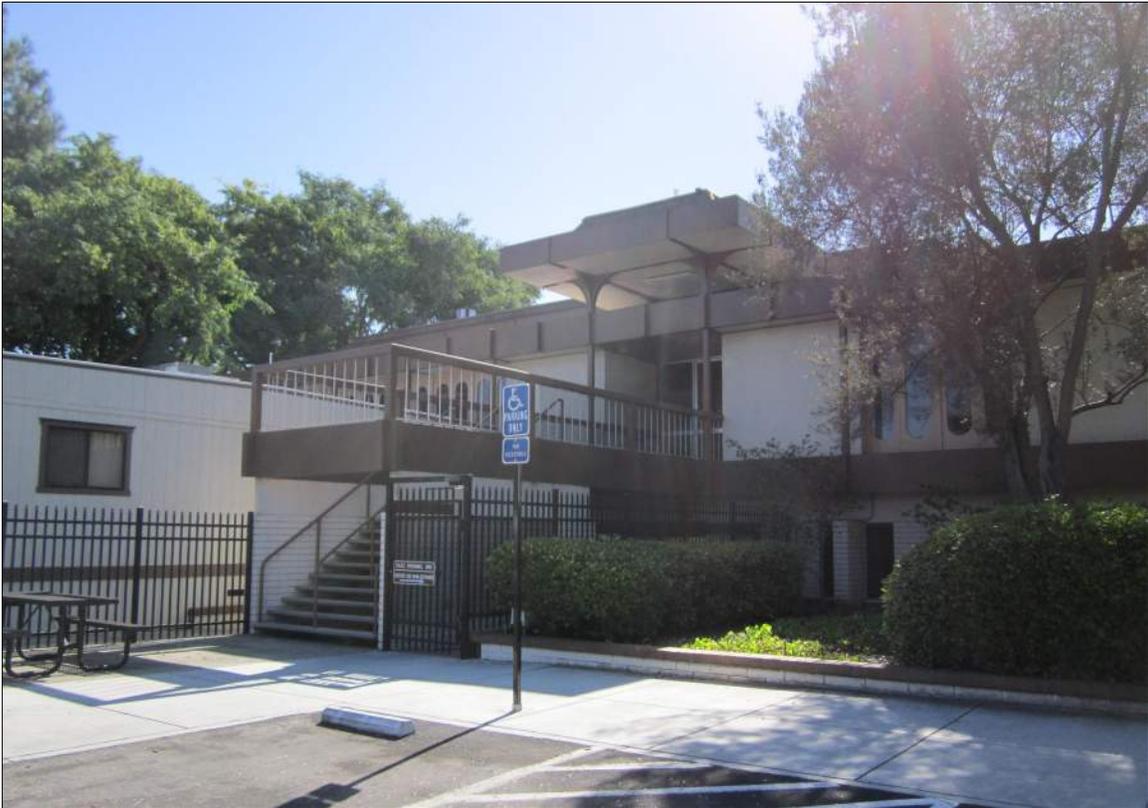
Photo 5 – North elevation view

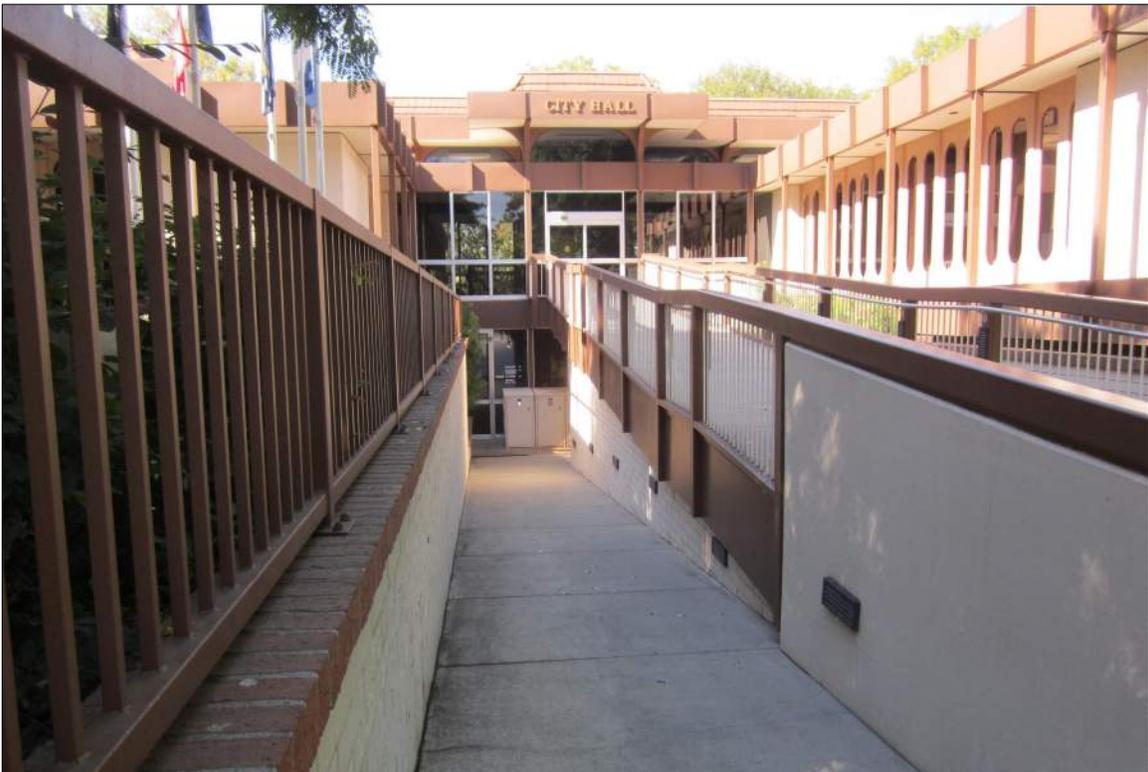
Photo 6 – Ramp at East entrance

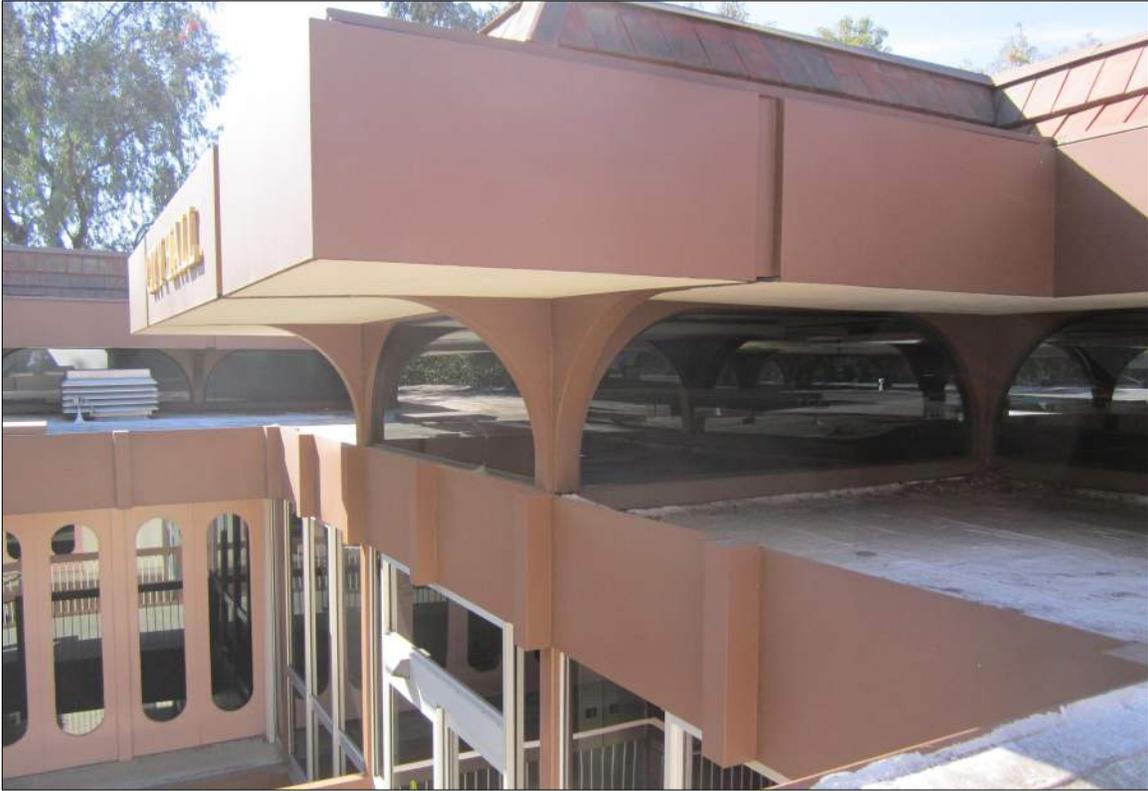
**Photo 7 – High roof with steel cantilevered columns**

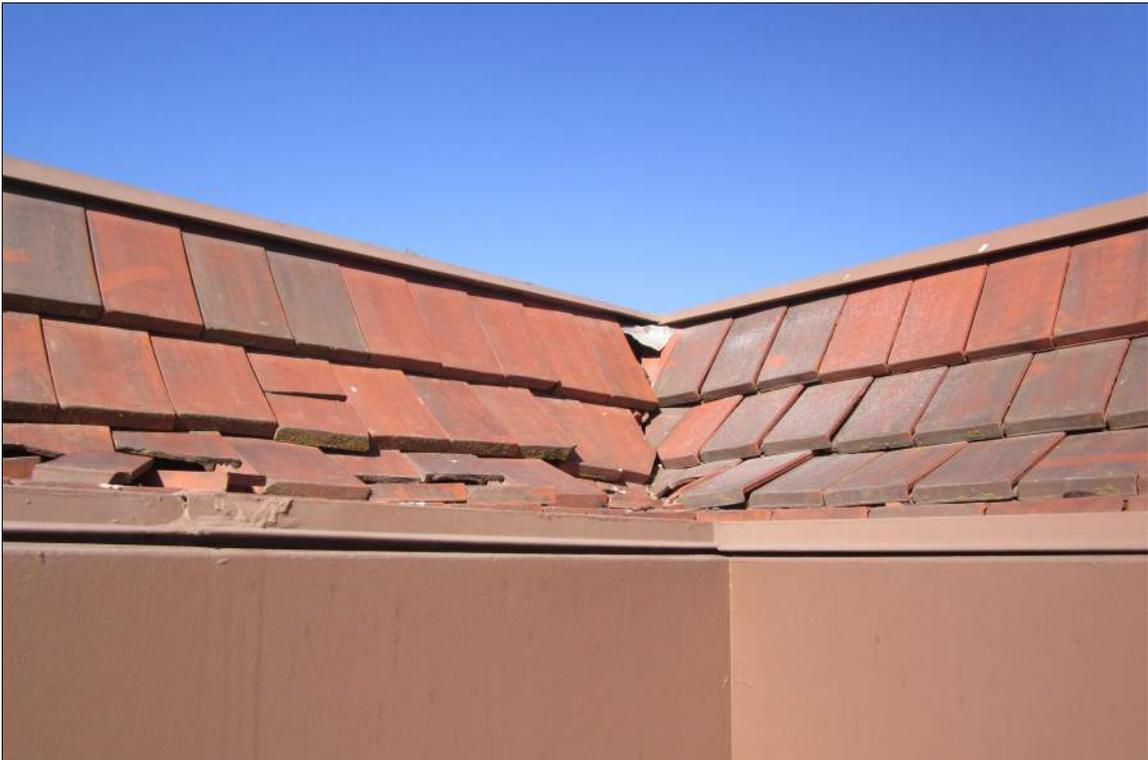
**Photo 8 – Broken tiles at upper roof**

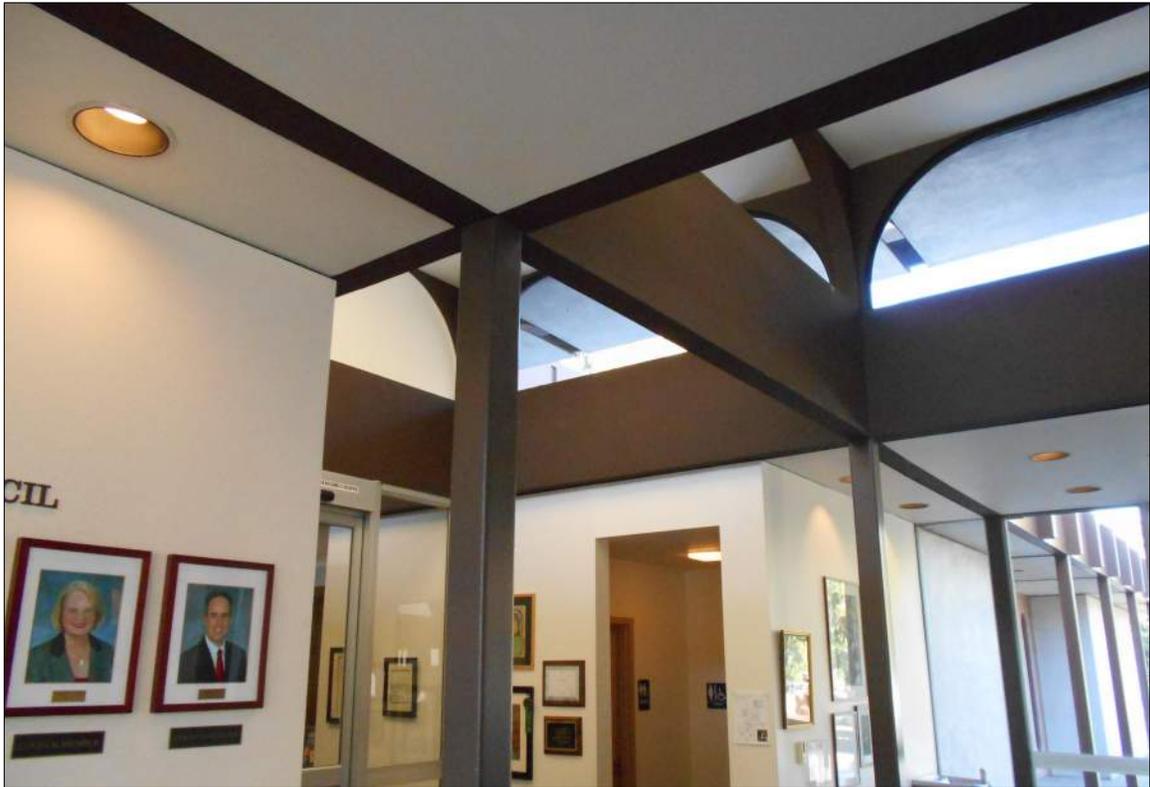
Photo 9 – Interior steel columns at second floor

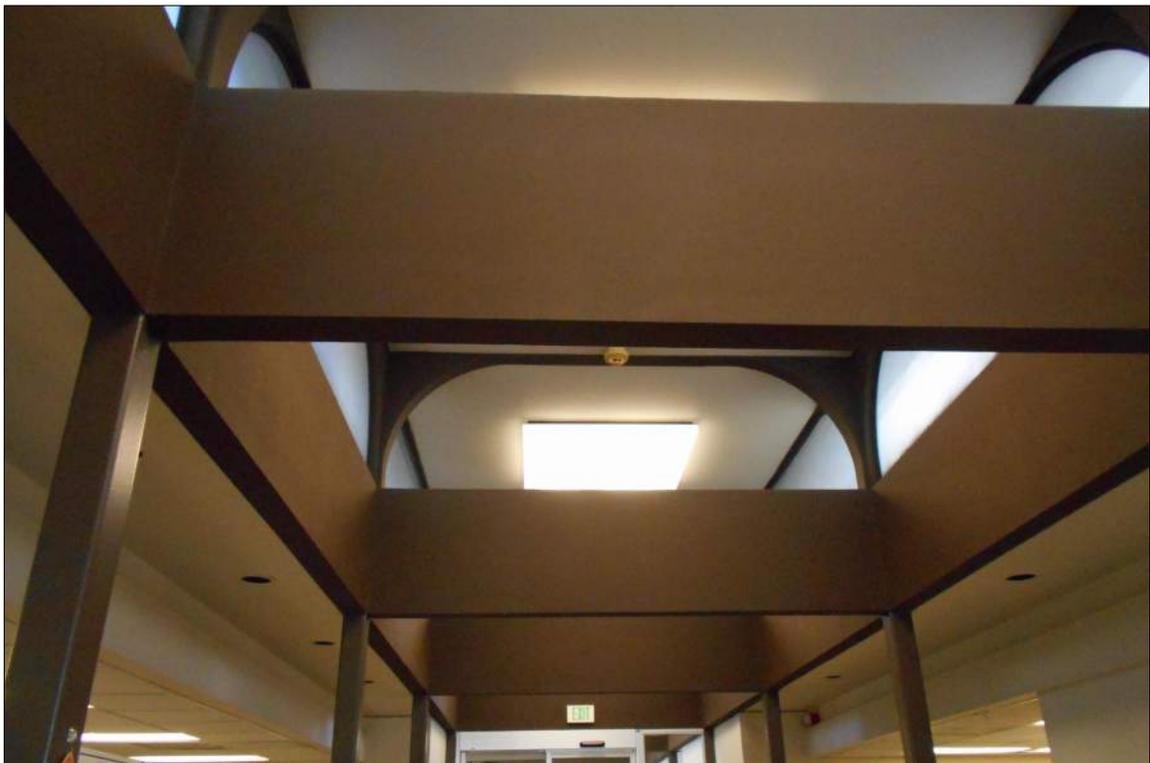
Photo 10 – Interior open roof framing below upper roof

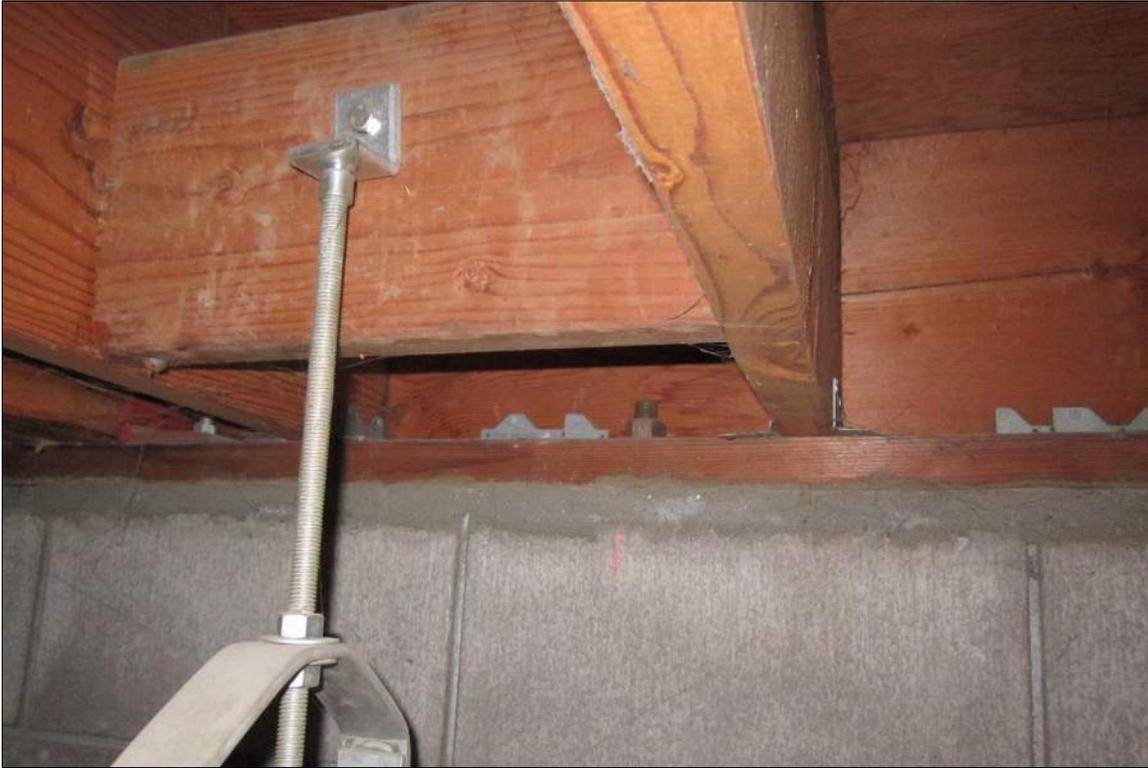
Photo 11 – Bolted wood sill plate at masonry wall

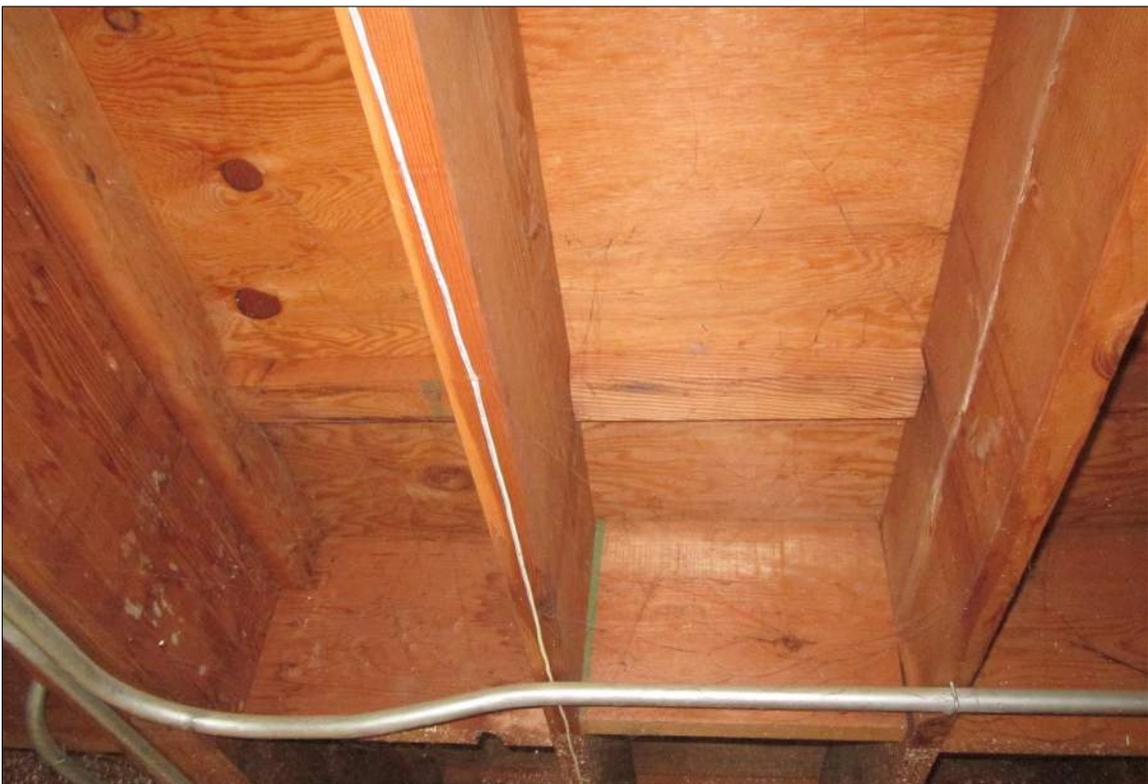
Photo 12 – Wood floor joists

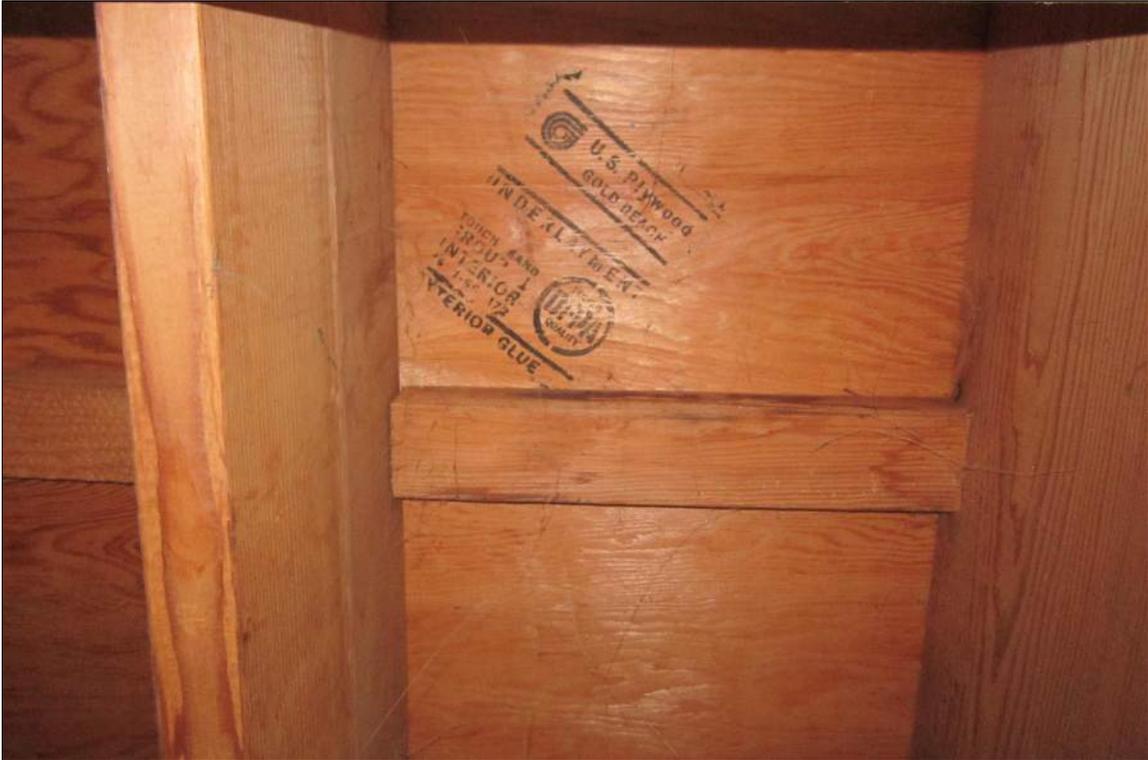
Photo 13 – Wood blocking at plywood diaphragm

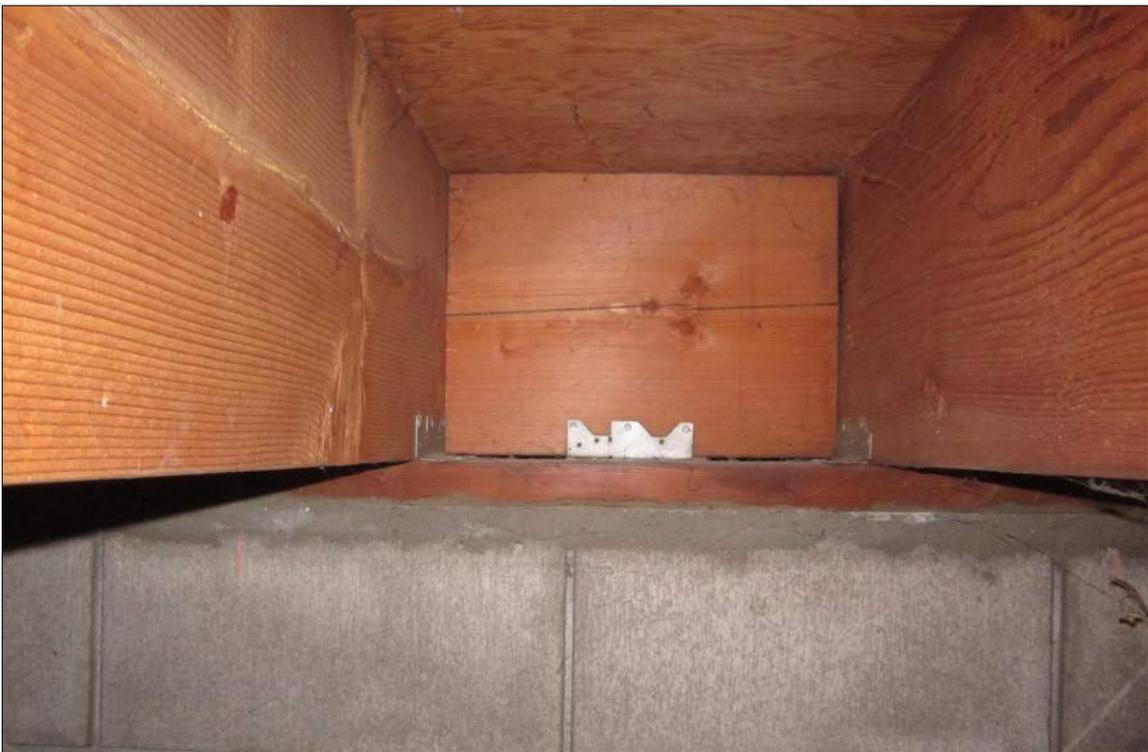
Photo 14 – Simpson steel clips at floor framing

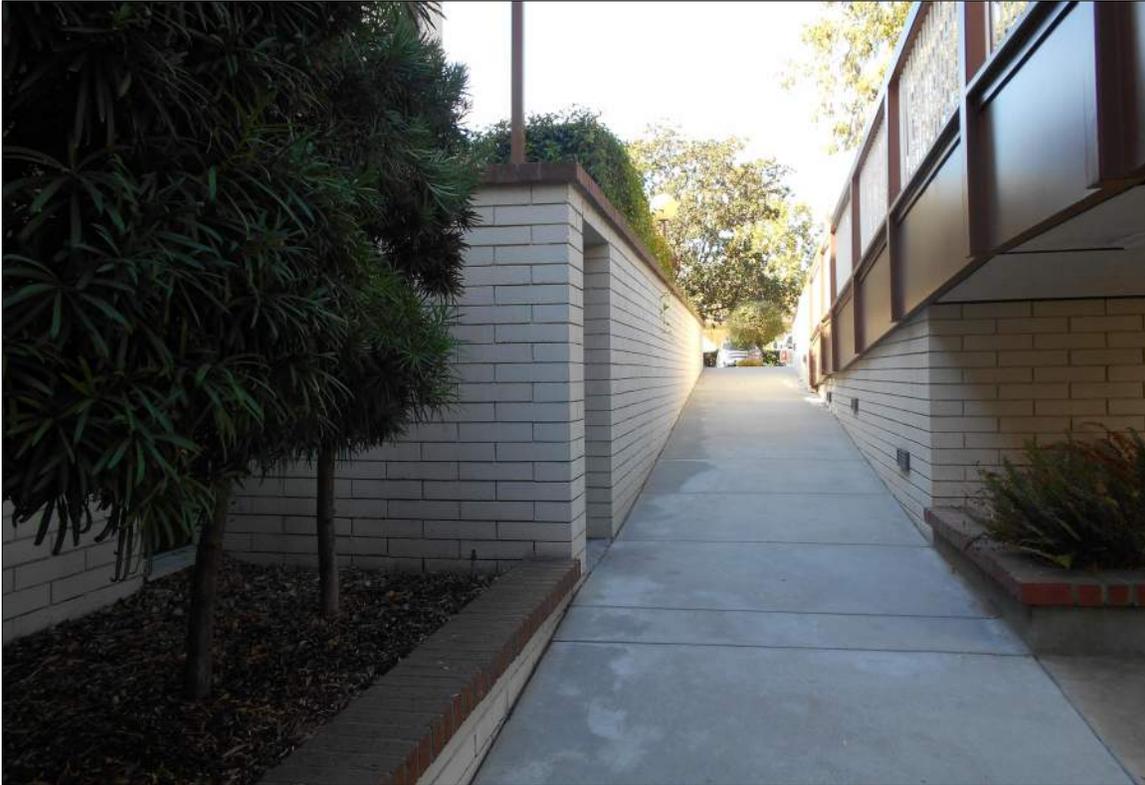
Photo 15 – Ramp at West elevation

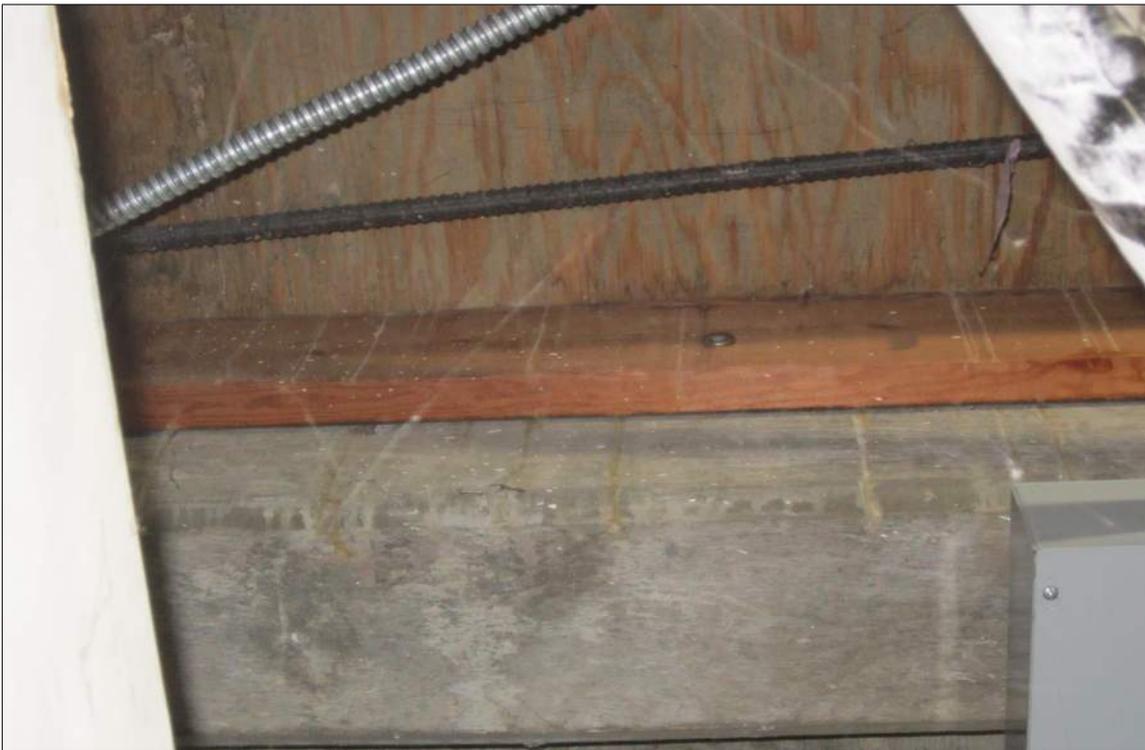
Photo 16 – Wood ledger at concrete vault

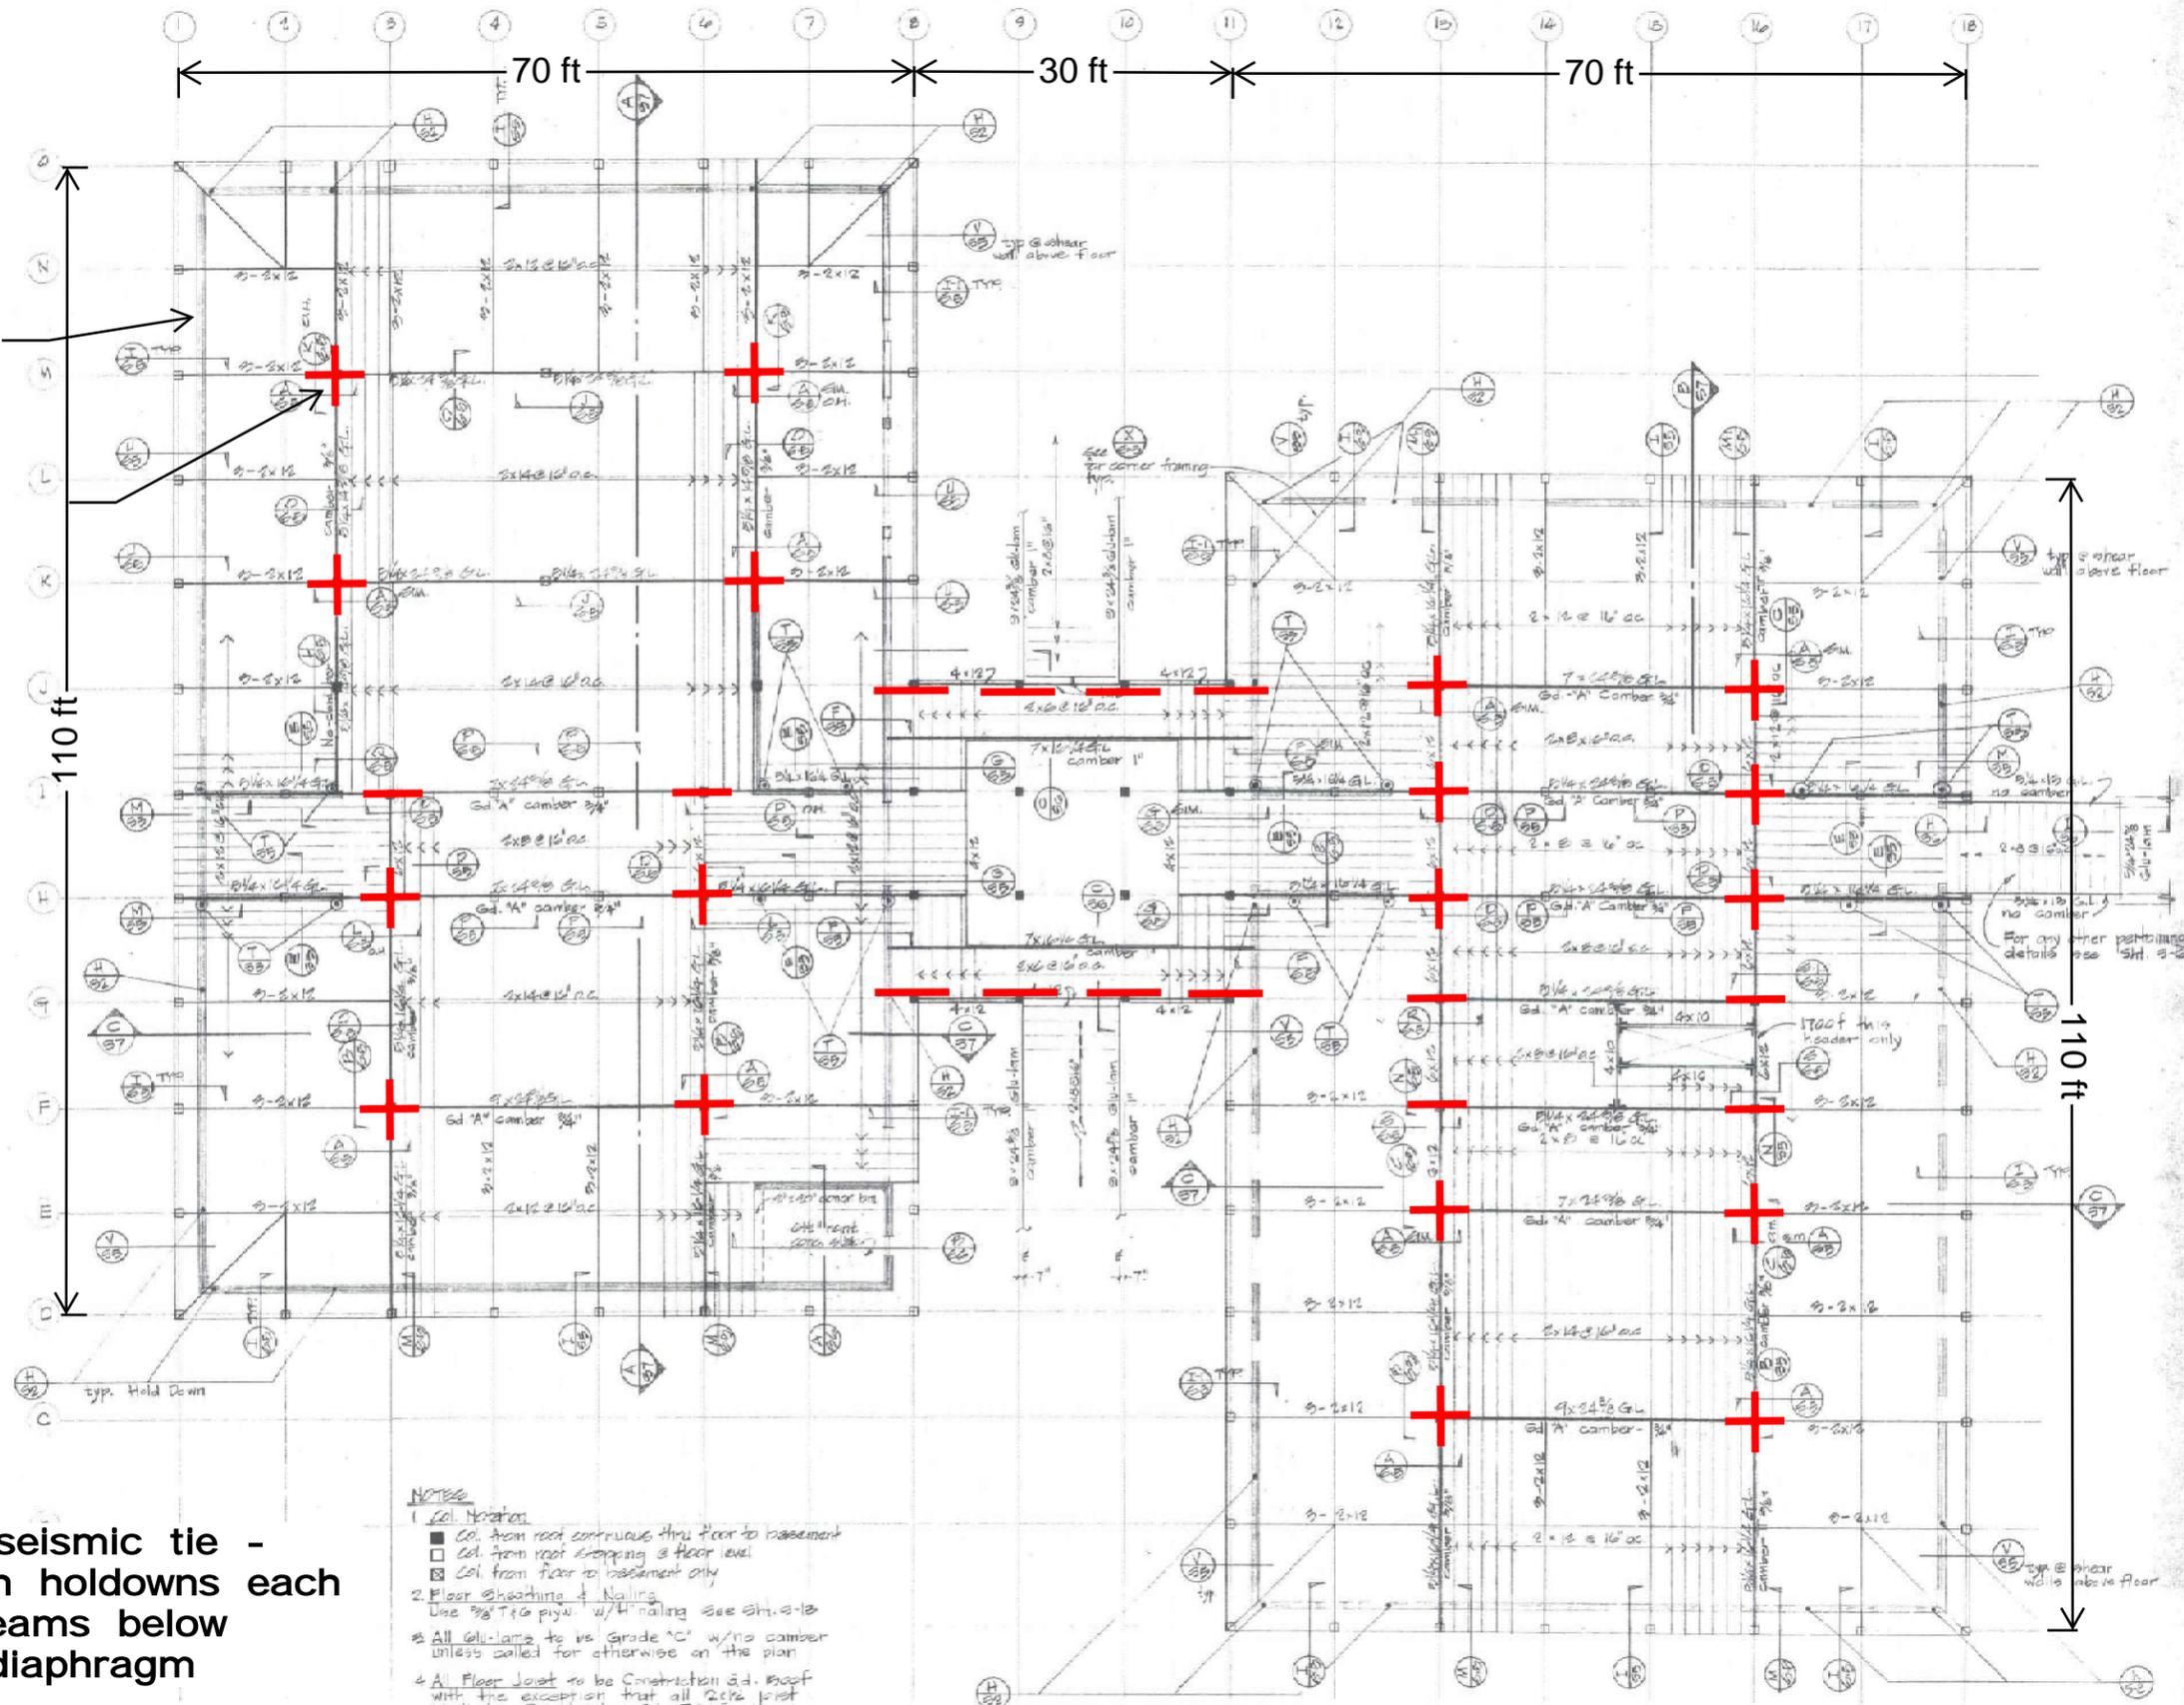
**SECOND FLOOR PLAN**

1. At low roof level, collectors along shear wall lines are inadequate for transferring the diaphragm load to the shear walls. Addition of new steel straps with blocking between joists is required.
2. At second floor level, building cross-ties are inadequate for transferring out-of-plane masonry wall loads into the floor diaphragm. Addition of new horizontal steel straps or steel rods with holdowns is required at beam splice locations (typically at columns).
3. At the second floor level, the wood shear walls are inadequate to transfer in-plane seismic loads. Addition of new plywood at the existing shear walls along with steel straps, and steel rods with holdowns are required.

1. At low roof level, provide new collectors along shear wall lines by adding new steel straps over plywood sheathing, with new blocking between the joists. [See Deficiency 1 above].
2. At second floor level, provide building cross-ties by adding new horizontal steel straps or steel rods with holdowns at beam splice locations (typically at columns). [See Deficiency 2 above].
3. At second floor level, provide new plywood at several existing shear walls along with new steel straps and steel rods with holdowns. [See Deficiency 3 above].

— Indicates (N) seismic tie - steel rods with holdowns each side of (E) beams below second floor diaphragm
