CAMPBELL CITY COUNCIL STUDY SESSION

Subject Study Session – Civic Center Master Plan

TIER 1 SEISMIC EVALUATION
Immediate Occupancy Structural Performance Level
Campbell City Hall
Campbell, California

TIER 1 SEISMIC EVALUATION
Immediate Occupancy Structural Performance Level
Campbell Library
Campbell, California

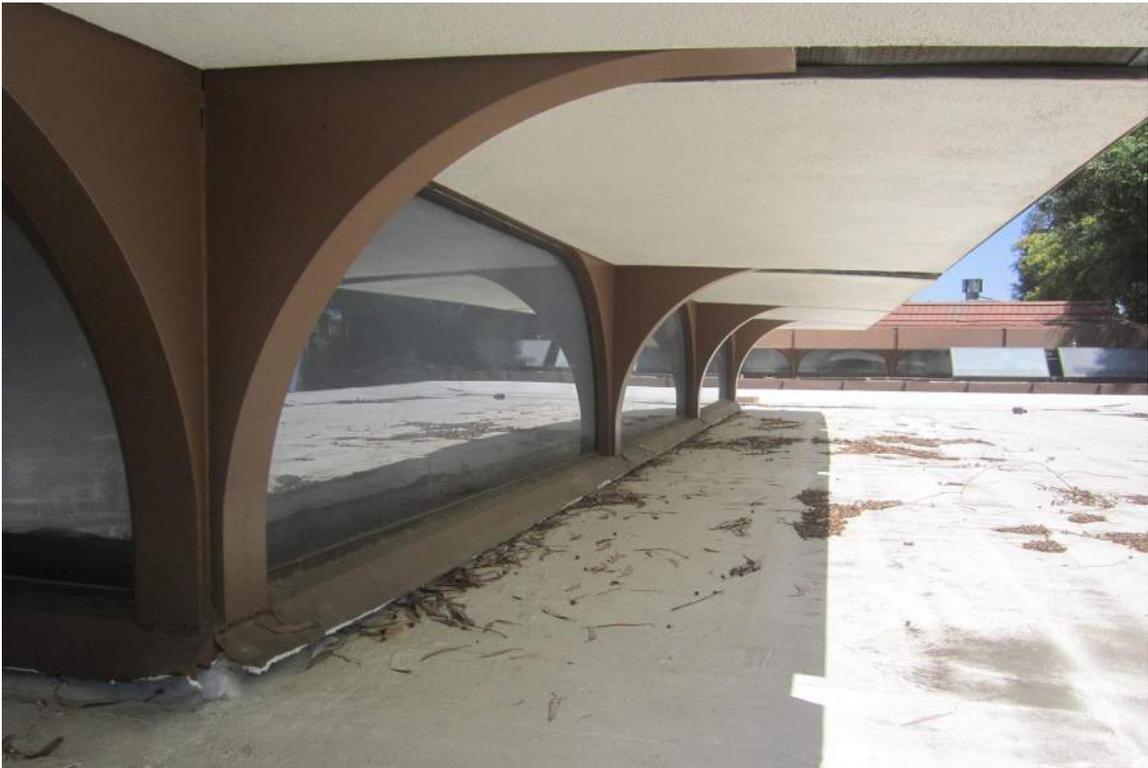
The shear capacities of the roof and second floor plywood diaphragms appear to be adequate for transferring the seismic forces to the shear walls; the details and capacities of the roof diaphragm chords/collectors, however, need strengthening. The steel cantilever columns supporting the high roof appear to be inadequate for transferring the seismic forces into the main roof diaphragm. New lateral elements will need to be added in the clearstory between the high roof and low roof.

Photo 8 – Clearstory at High roof

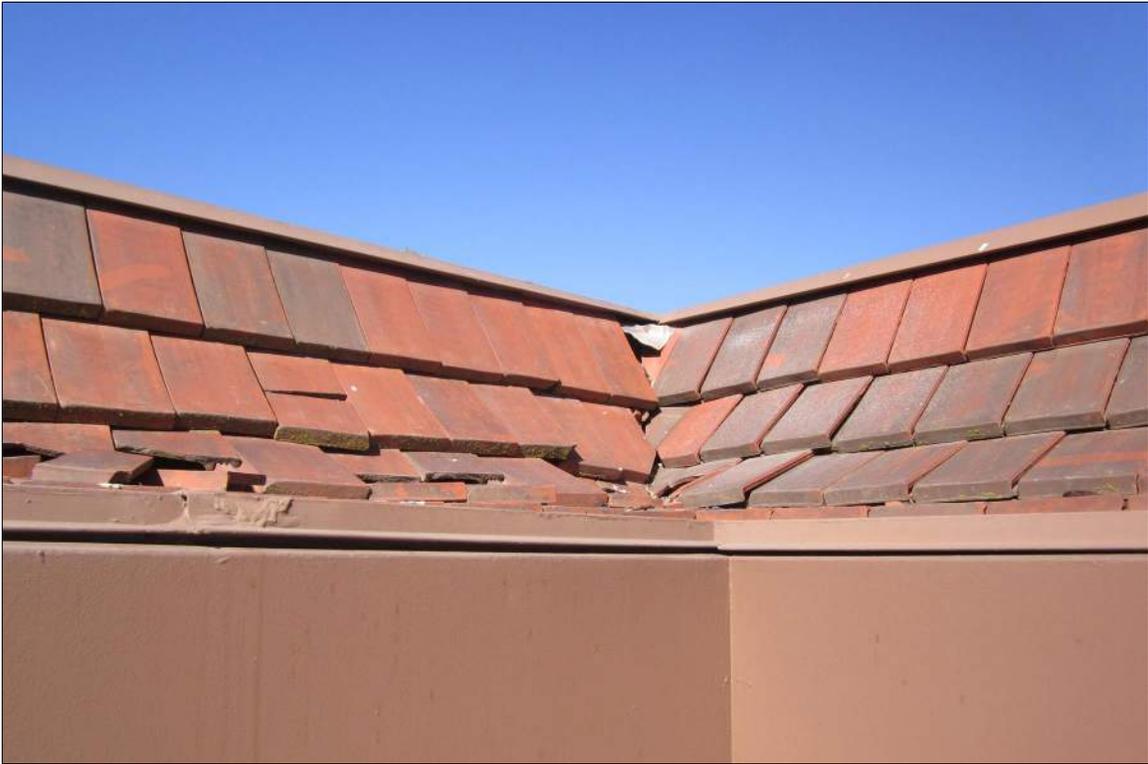
Photo 9 – Broken tiles at upper roof

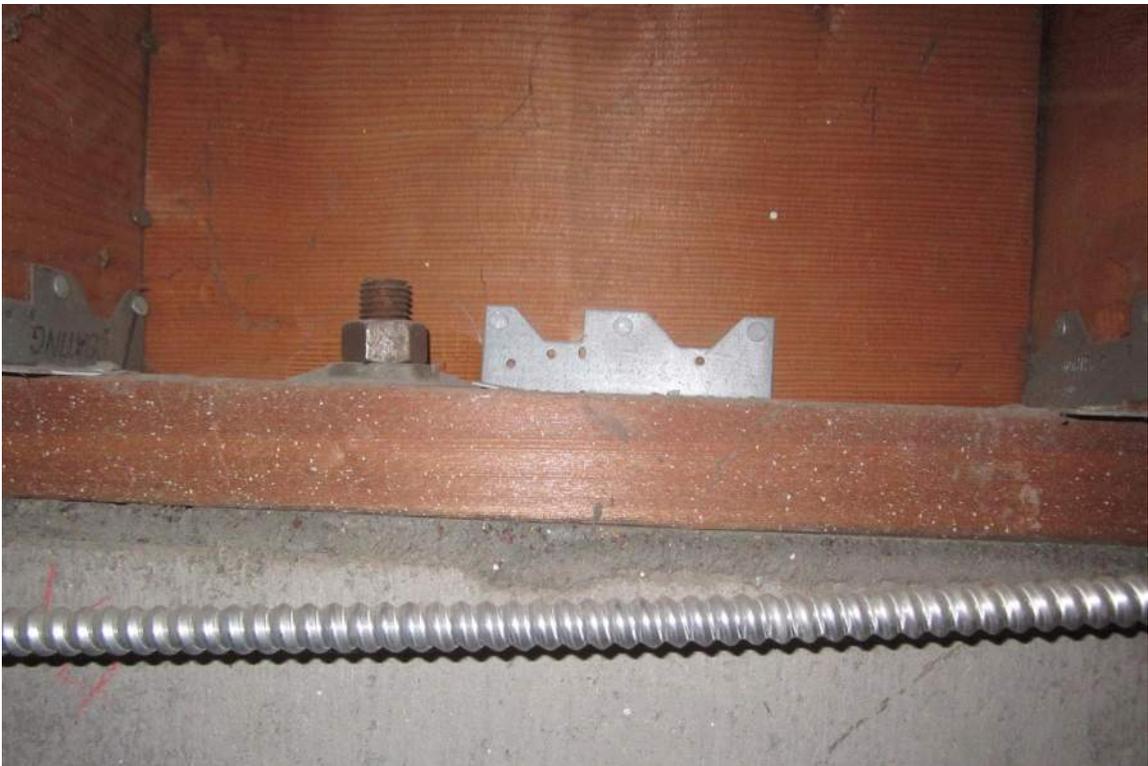
Based on the original structural drawings, the masonry shear walls at the first story are fully grouted and reinforced and appear to be adequate for transferring the in-plane seismic loads to the foundations. The in-plane shear connection between the second floor diaphragm and the masonry walls below consists of wood blocking and steel angle clips attached to a continuous wood sill plate with anchor bolts embedded into the masonry wall at each joist. This connection appears to be inadequate for transferring the seismic loads. New anchor bolts will need to be drilled and epoxied through the wood sill and into the masonry walls.

Photo 12 – Bolted wood sill plate at masonry wall

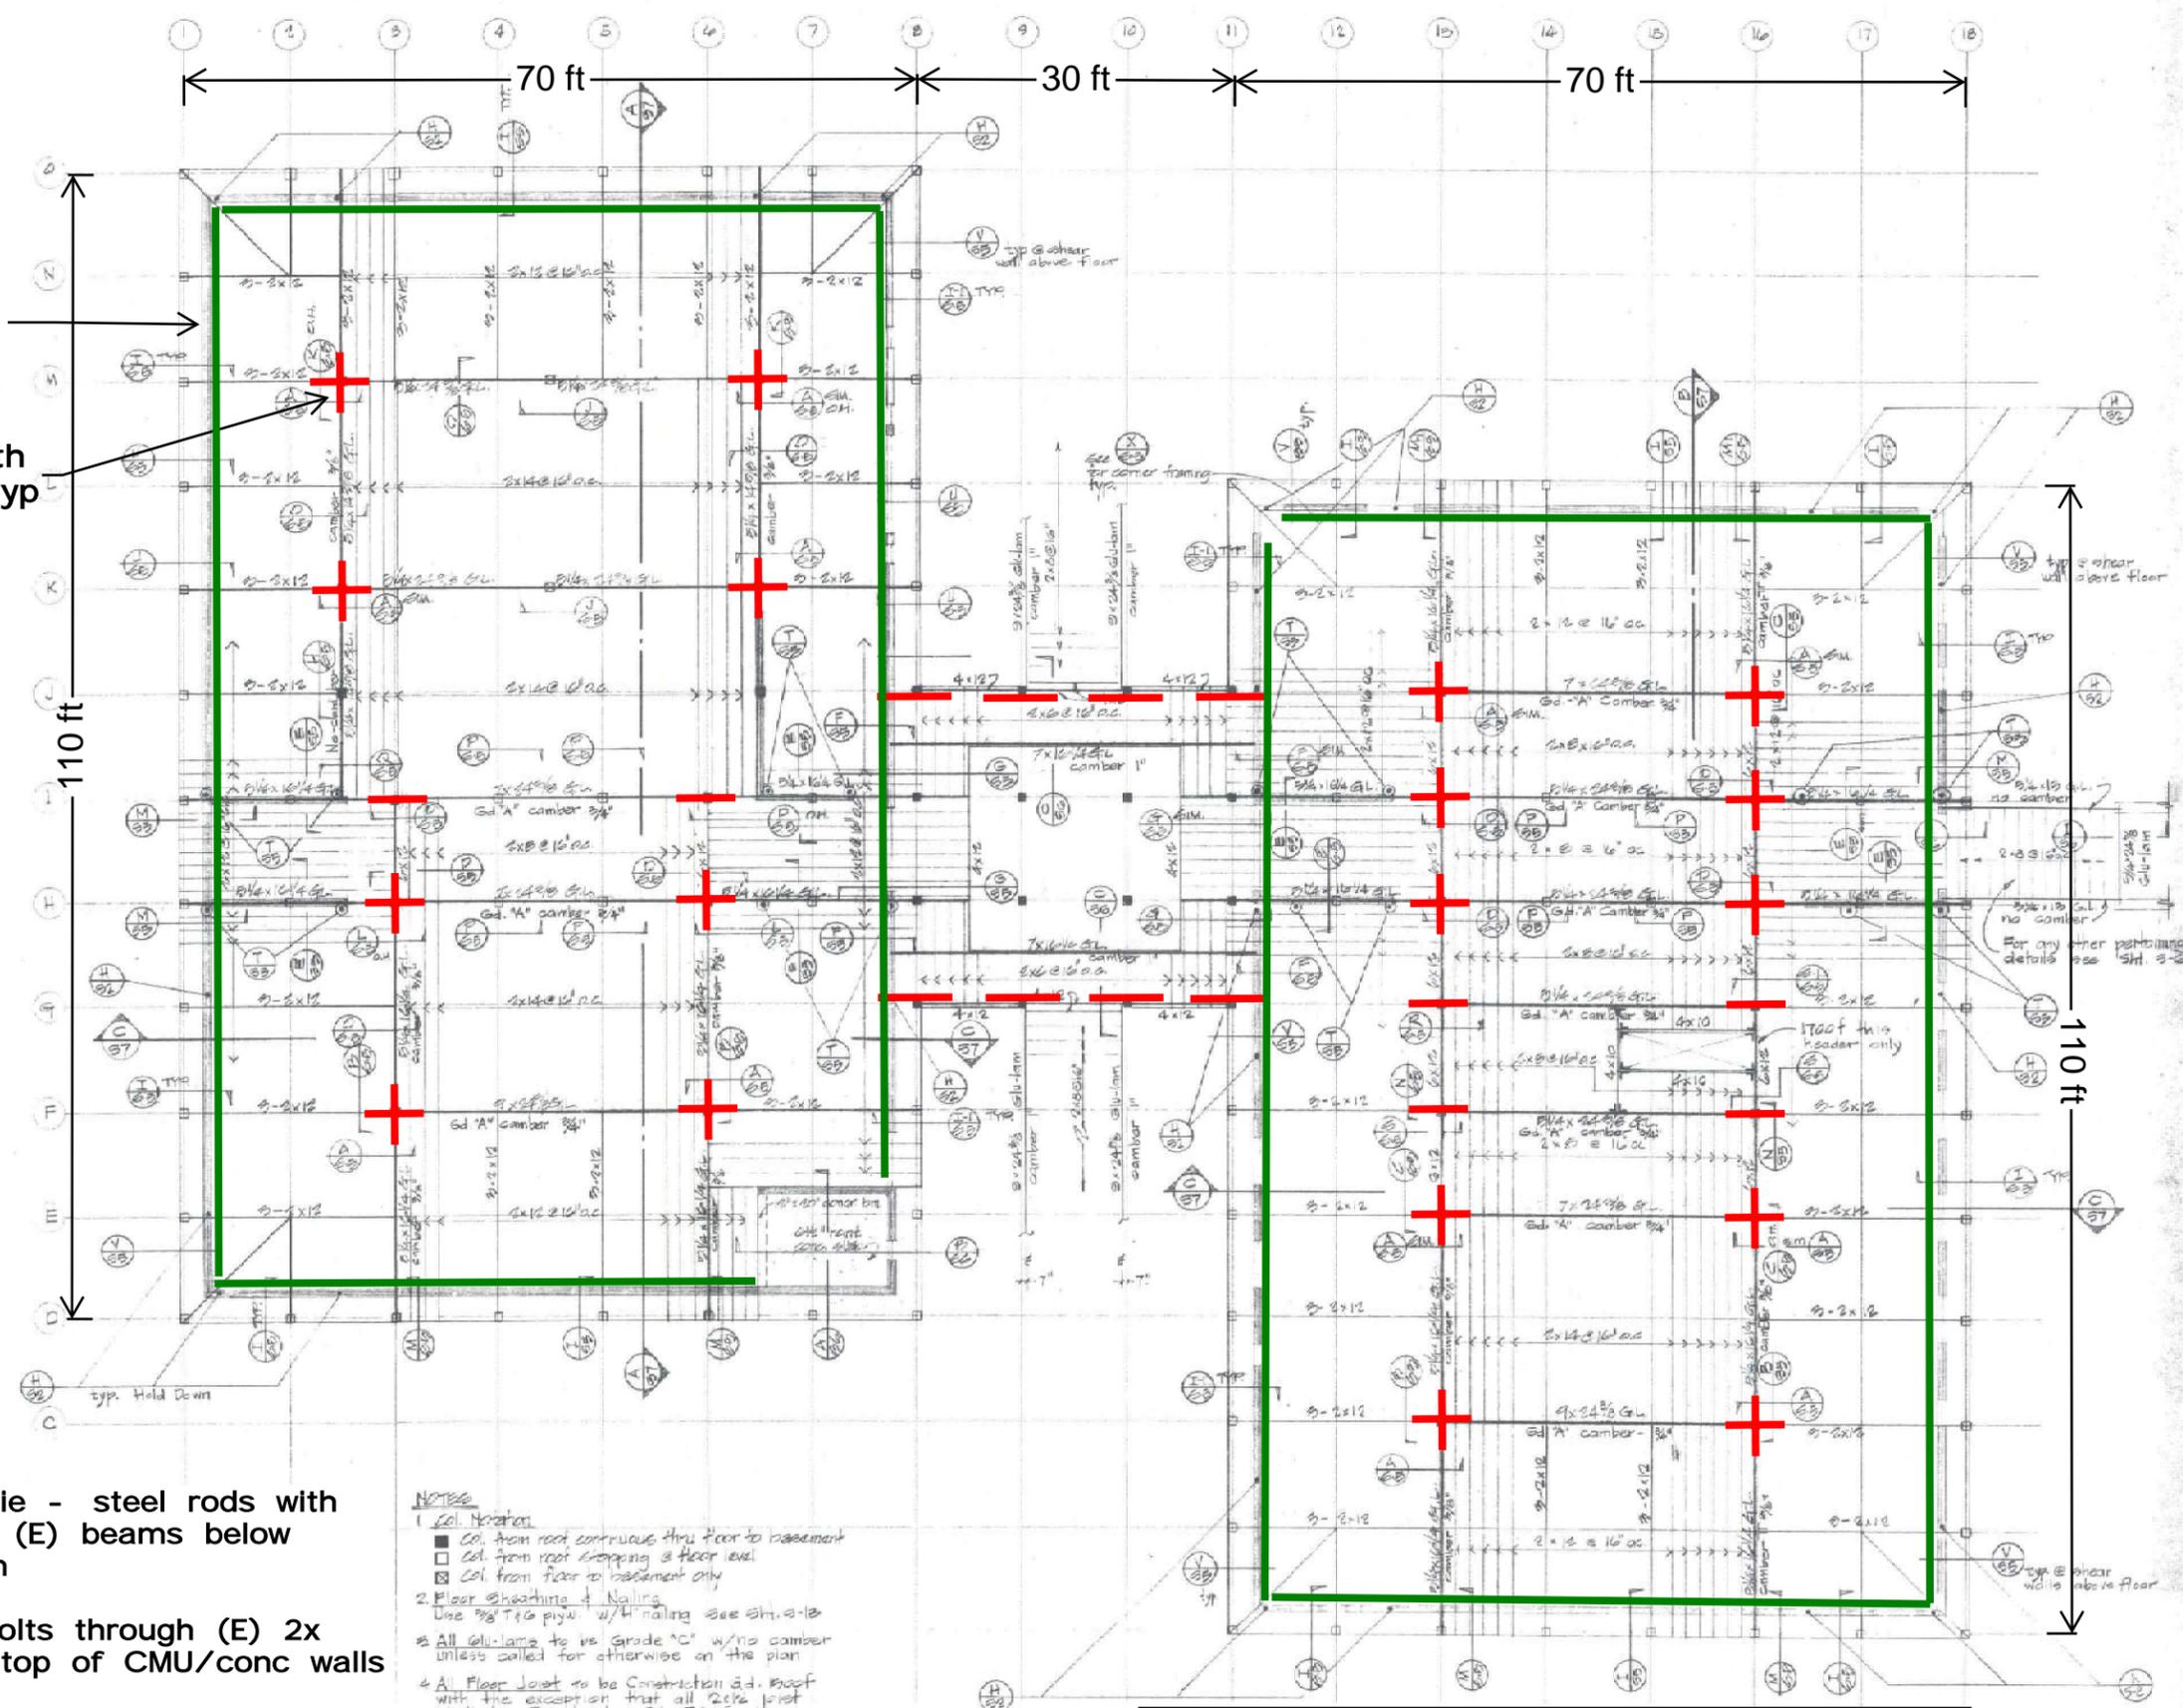
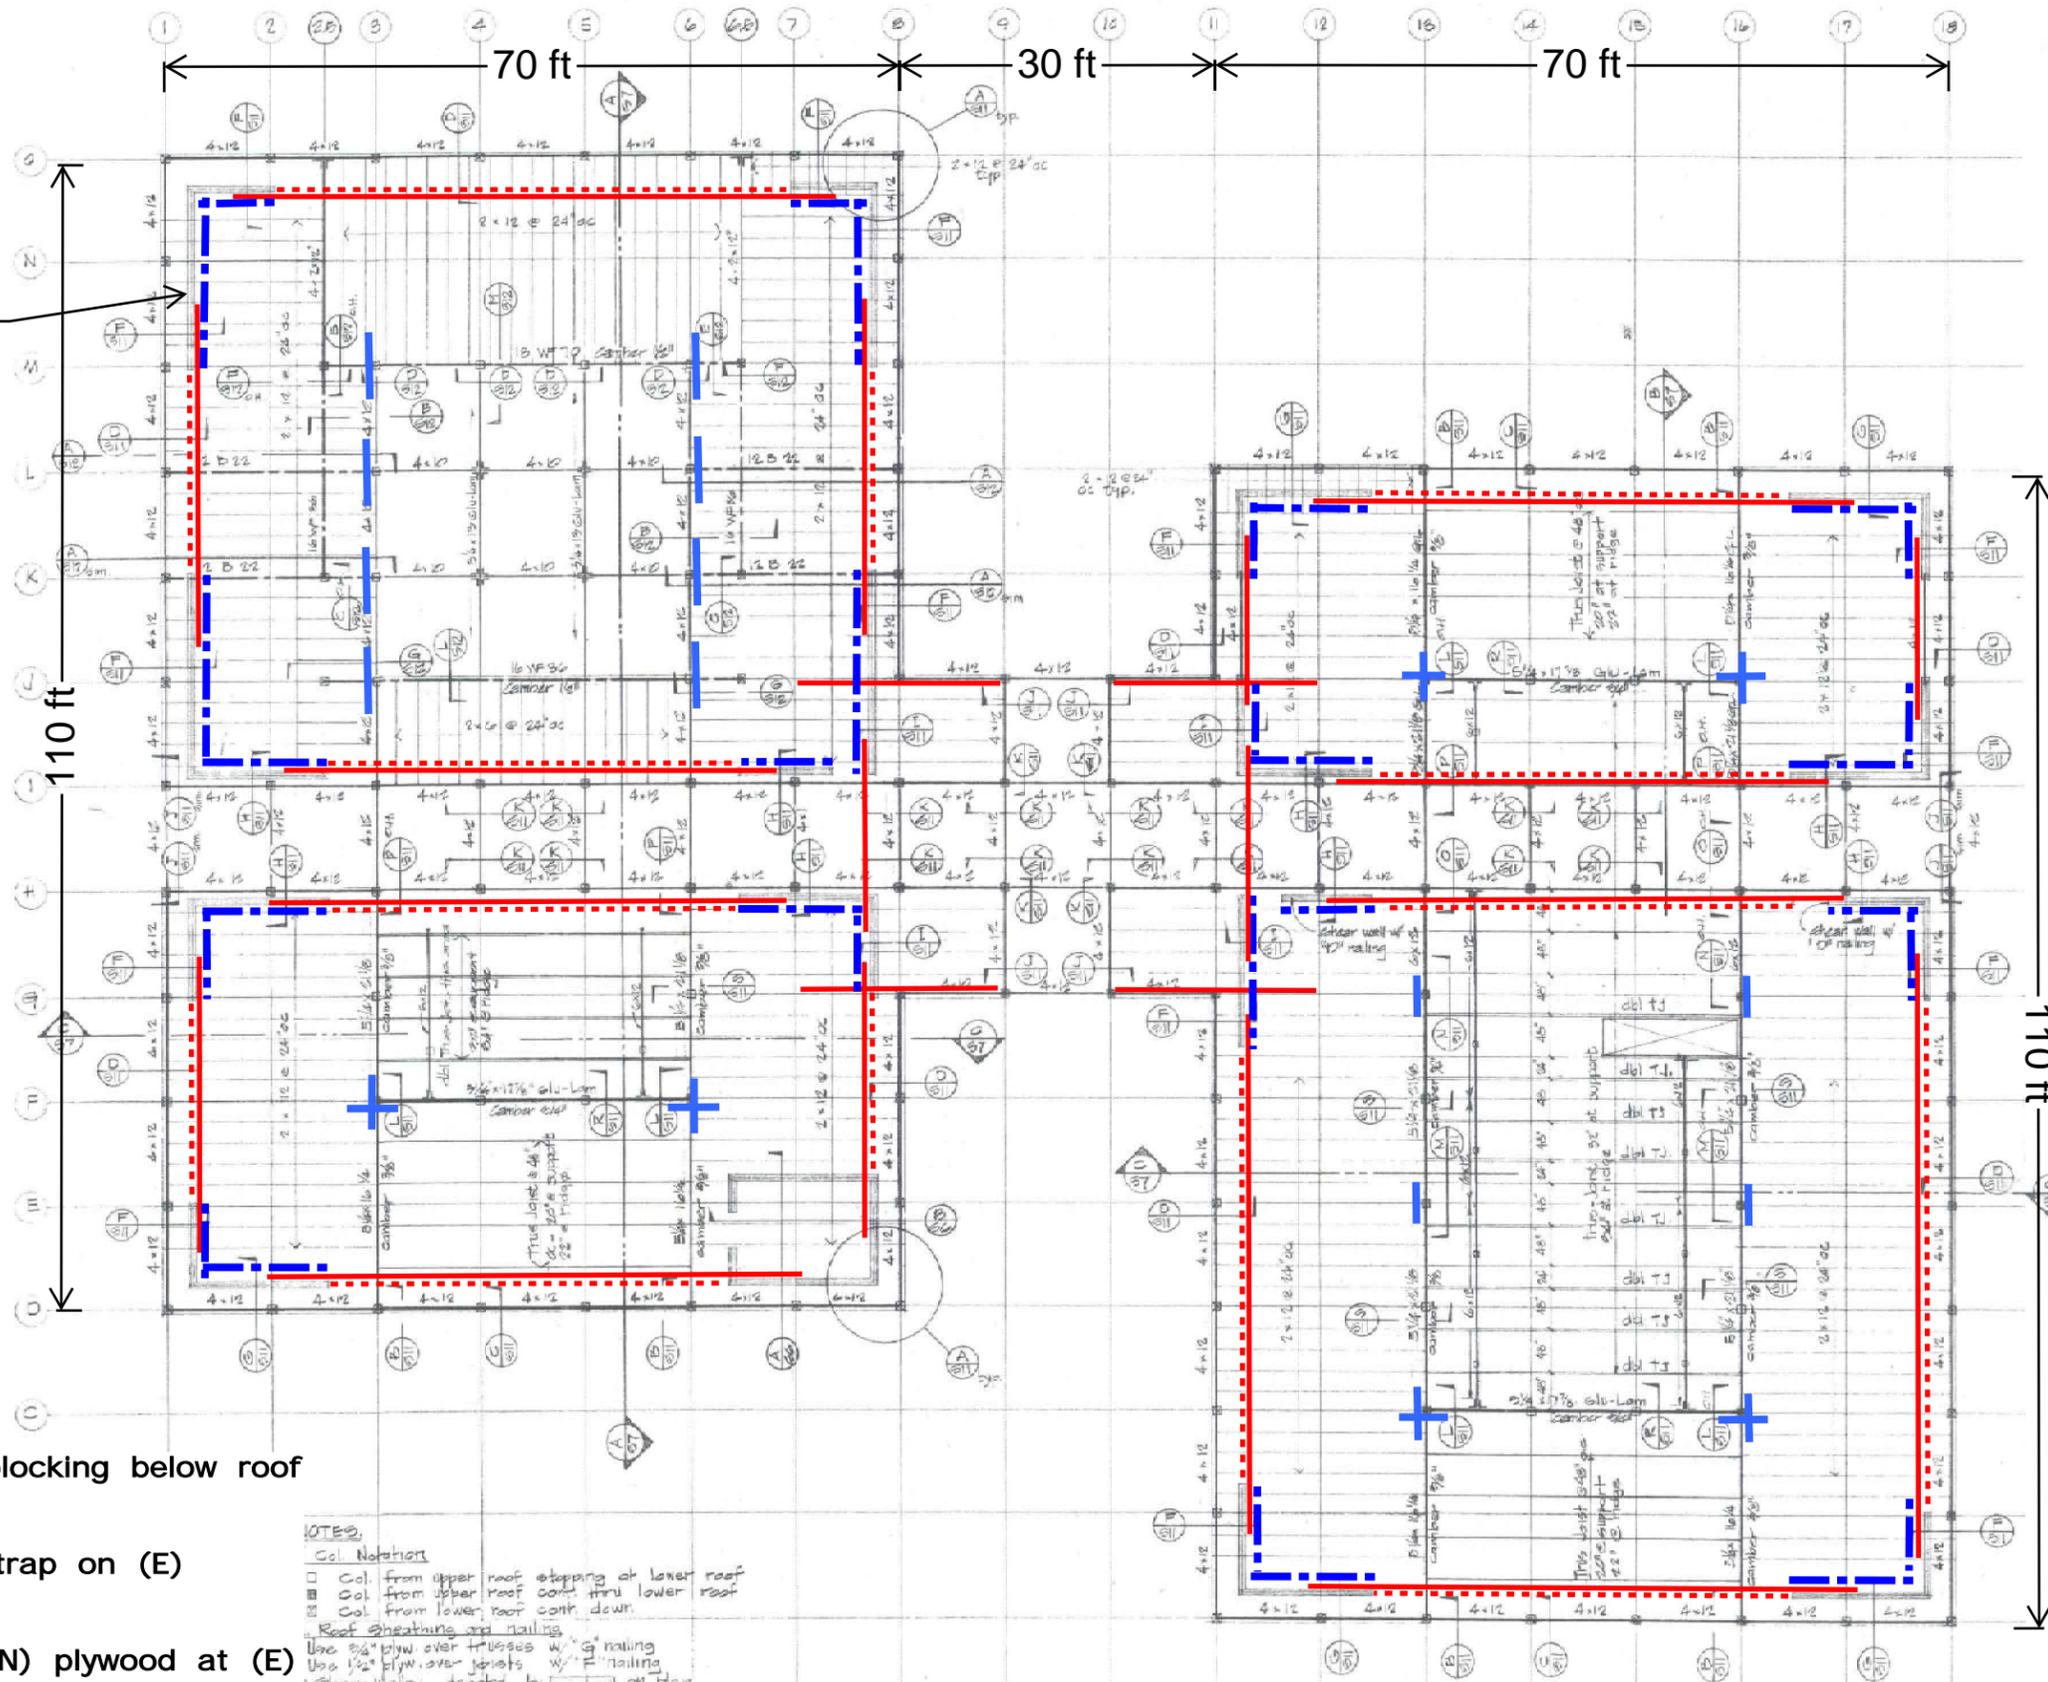
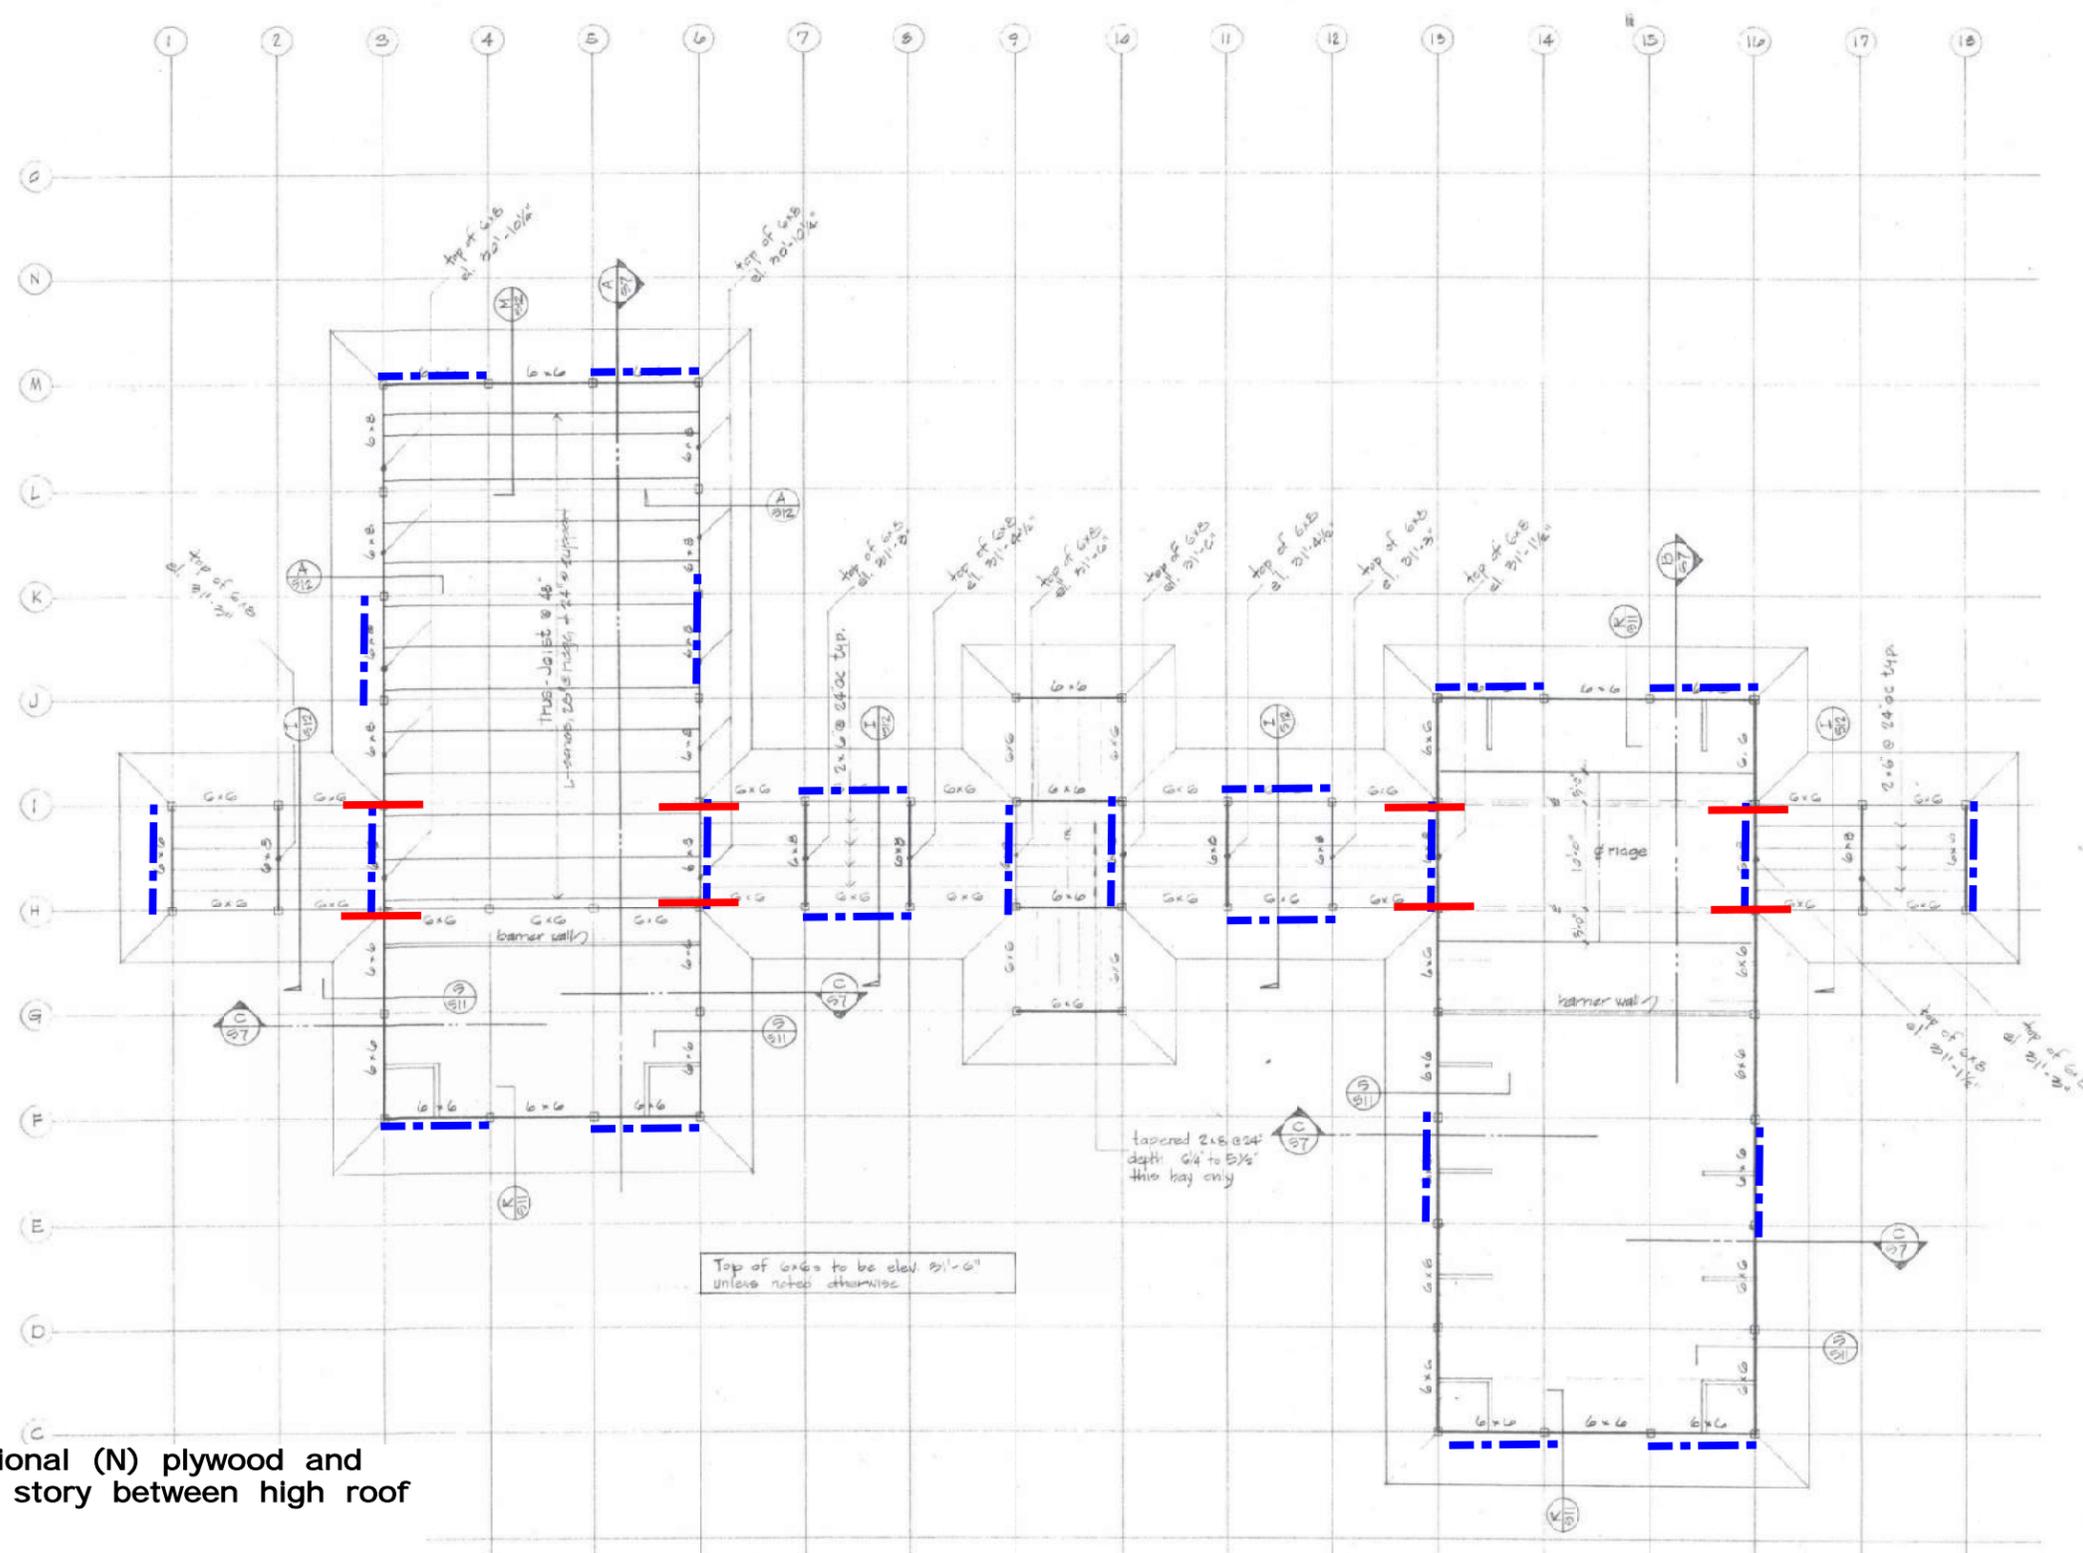
Conceptual Seismic Retrofit Plans

1. At low roof level, collectors along shear wall lines are inadequate for transferring the diaphragm load to the shear walls. Addition of new steel straps with blocking between joists is required.
2. At second floor level, building cross-ties are inadequate for transferring out-of-plane masonry wall loads into the floor diaphragm. Addition of new horizontal steel straps or steel rods with holdowns is required at beam splice locations (typically at columns).

3. At the second floor level, the wood shear walls are inadequate to transfer in-plane seismic loads. Addition of new plywood at the existing shear walls along with steel straps, and steel rods with holdowns is required.
4. At the second floor level, the masonry wall-to-floor connections appear to be inadequate for both in-plane and out-of-plane wall loads. The addition of new anchor bolts will be required.
5. At the high roof level the steel cantilever columns are inadequate for transferring seismic loads into the main roof diaphragm. New infill stud walls with plywood sheathing are required.

1. At low roof level, provide new collectors along shear wall lines by adding new steel straps over plywood sheathing, with new blocking between the joists. [See Deficiency 1 above].
2. At second floor level, provide building cross-ties by adding new horizontal steel straps or steel rods with holdowns at beam splice locations (typically at columns). [See Deficiency 2 above].
3. At second floor level, provide new plywood at several existing shear walls along with new steel straps and steel rods with holdowns. [See Deficiency 3 above].
4. At the second floor level, provide new anchors bolts drilled through the existing wood sill plate and epoxied into the top of the existing masonry walls. [See Deficiency 4 above].
5. At the high roof level, provide several new infill wood stud walls with new plywood sheathing at the clearstory between the low roof diaphragm and high roof diaphragm.

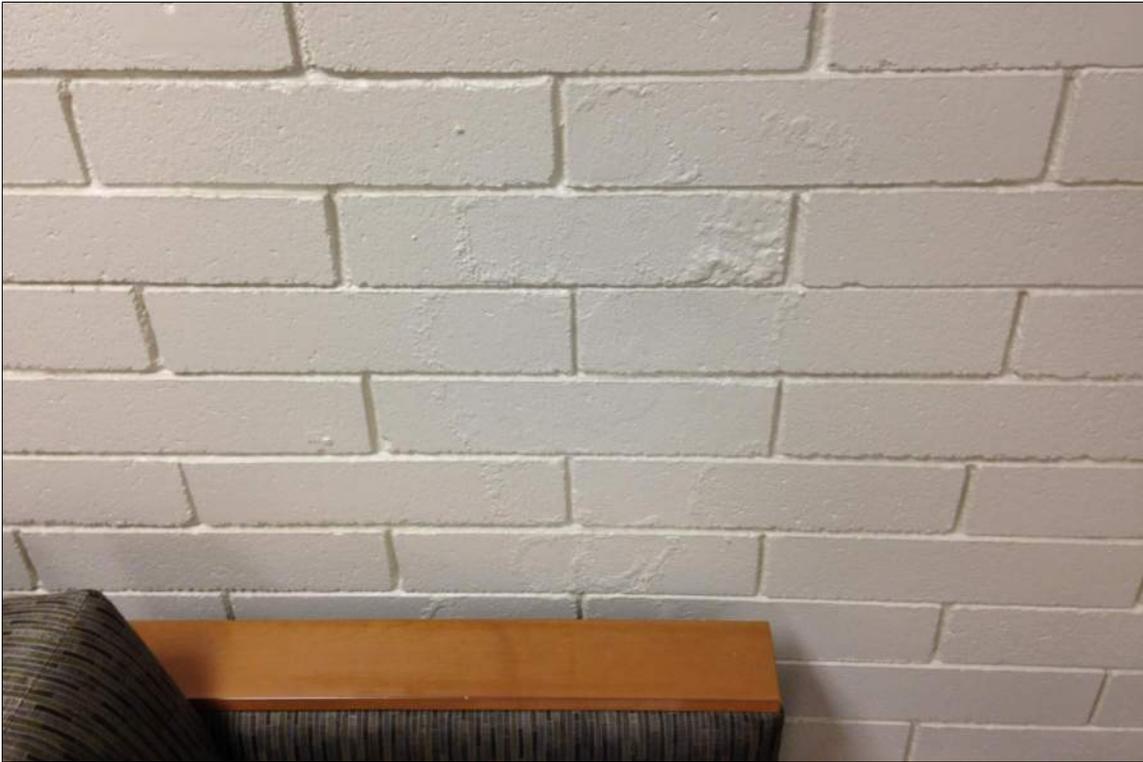
Photo 15 – Signs of water intrusion through masonry wall

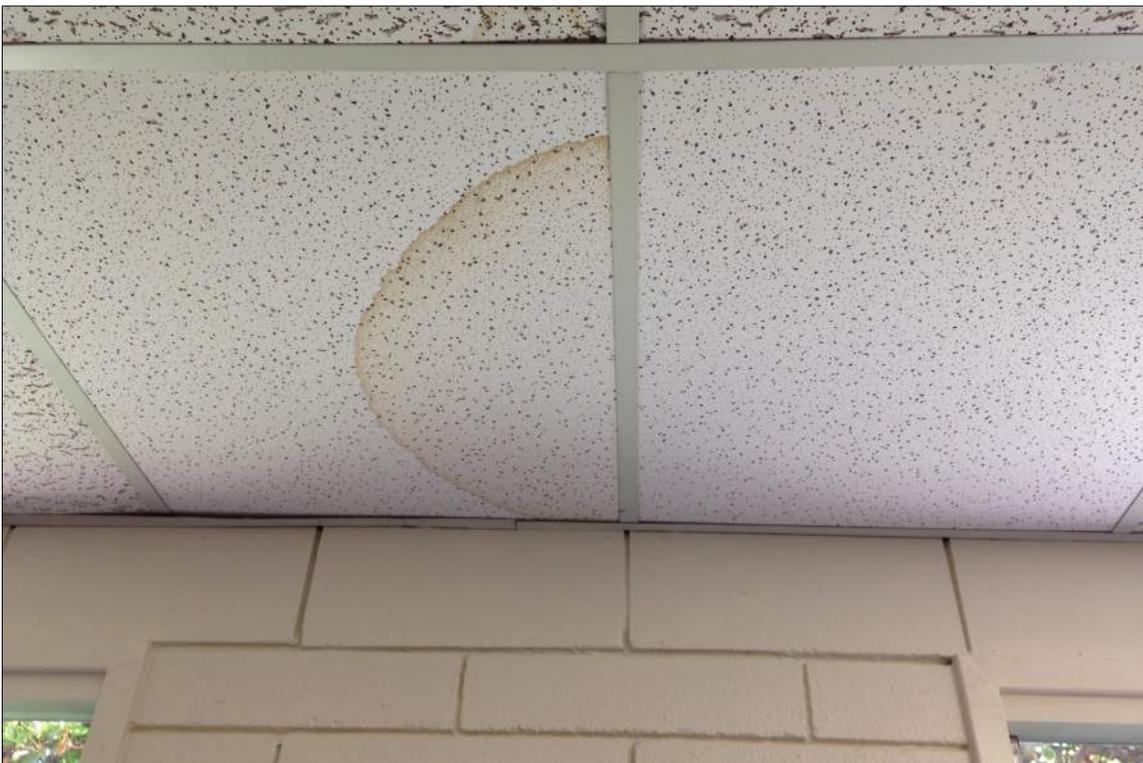
Photo 16 – Water damage at ceiling tile
